SECTION 1 – INTRODUCTION

PRINCETON PLACE III AT WIGGINS BAY

Site-Visit Date:
October 30, 2023

Report Date:
November 15, 2023

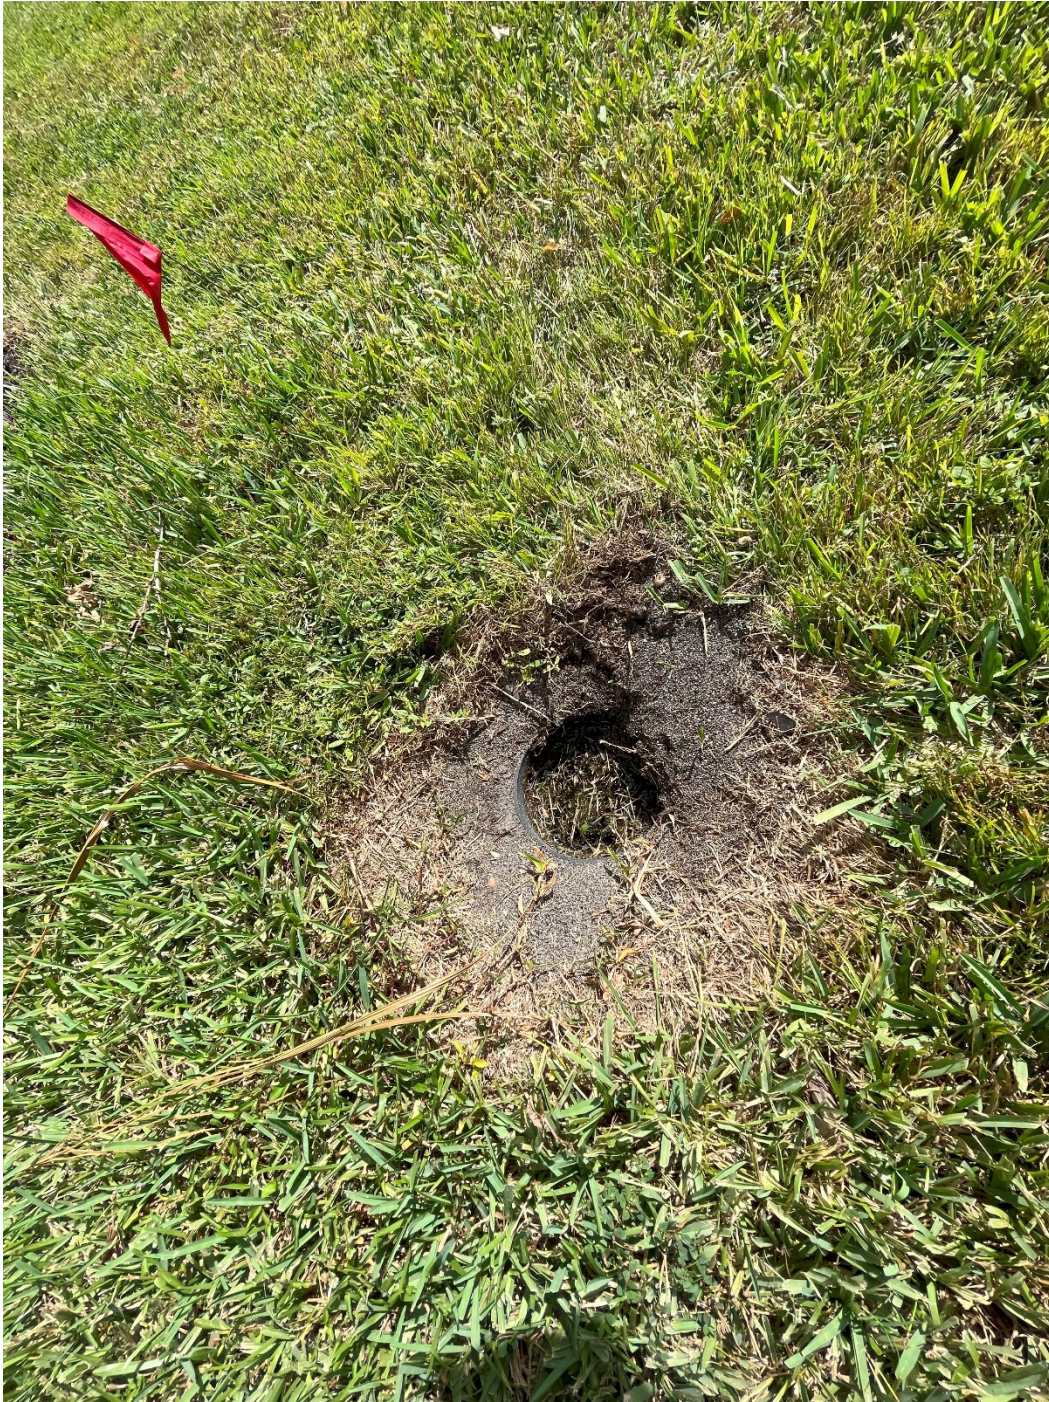
Unknown Hole in Yard

There was a curious hole in the yard of unknown purpose. It appeared to be clogged with soil and someone had placed a red survey flag near it to warn of the trip hazard. Suggest having a plumbing subcontractor evaluate the hole to see if it needs cleaning out and to install a cover to eliminate the trip hazard.

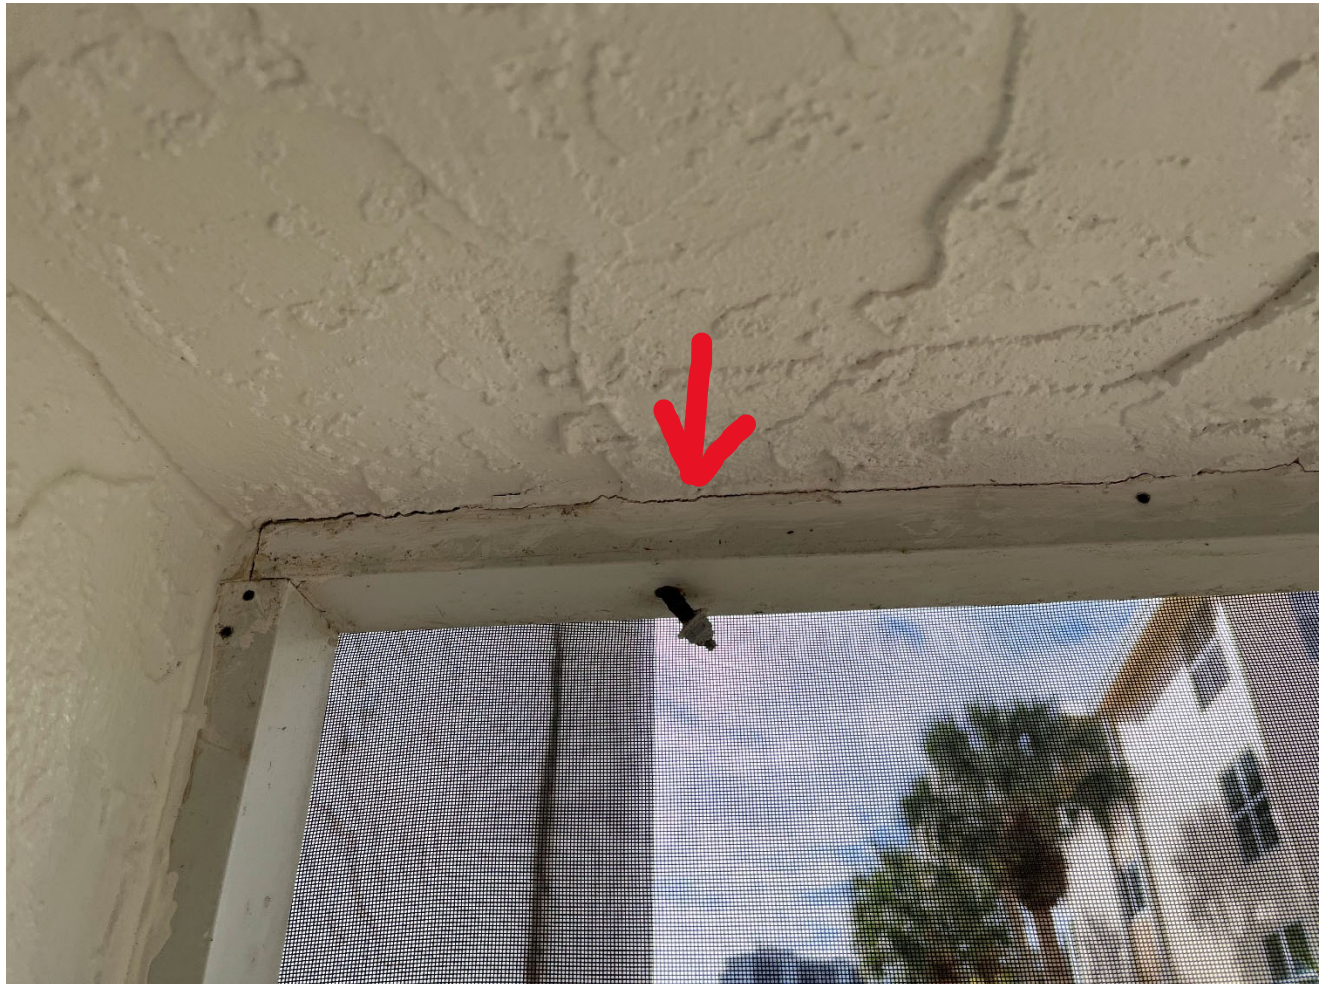
Unit 108 had a hairline crack over the top frame of the screen on the left side of the lanai. Since this is an outdoor location, it is important to keep any moisture from penetrating the stucco surface or get behind the screen framing where it can deteriorate the substrate materials. Also the bolt fastening this frame to the ceiling has hanging down and may be the result of underlying water damage. Suggest replacing this rusted bolt.

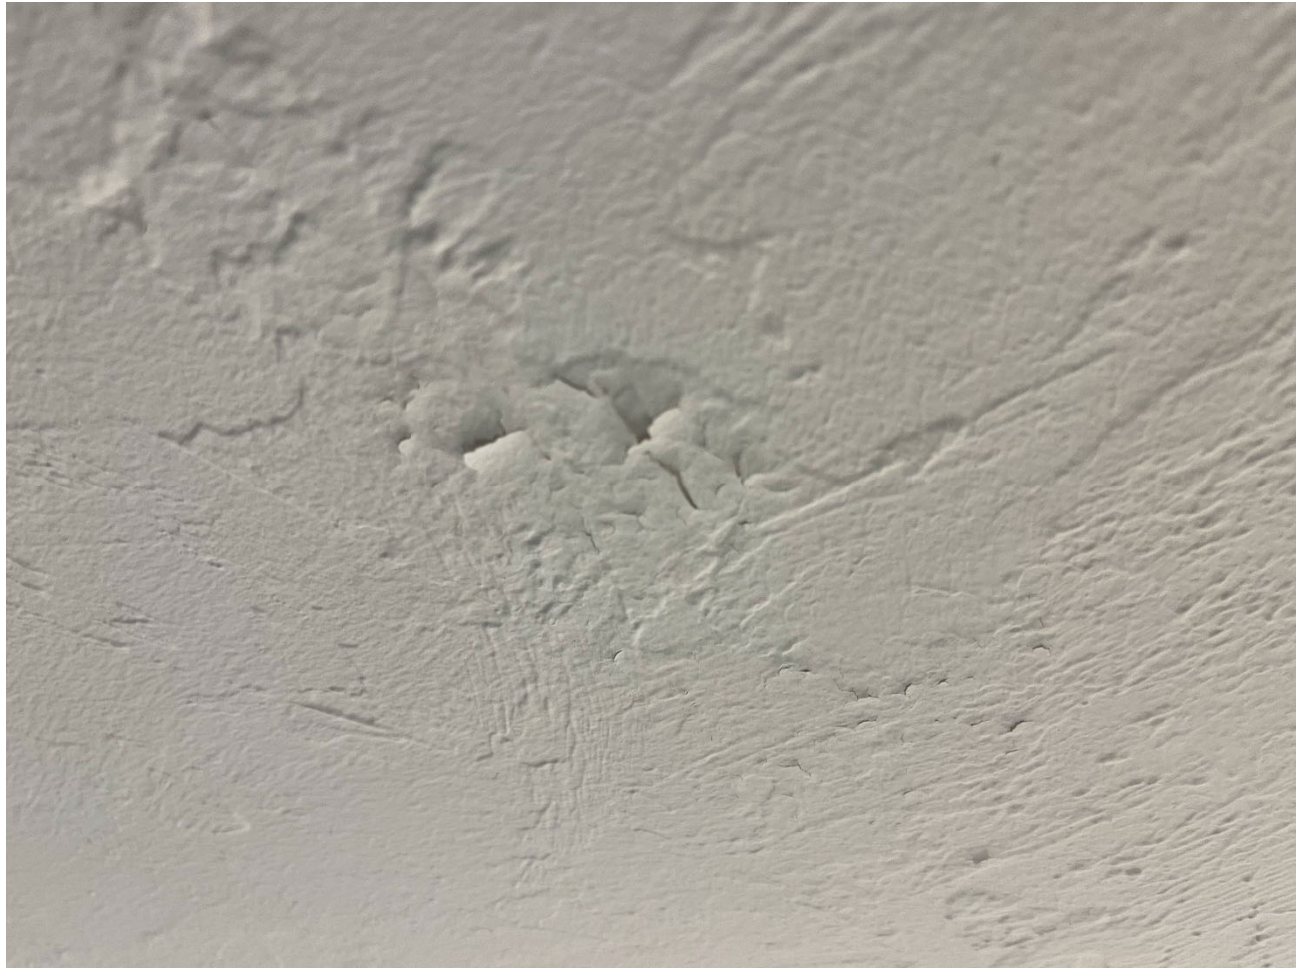
Unit 201 had a small crack in the ceiling of the master bath. Because of its proximity to the shower, it is important to fill and seal this crack to prevent moisture from getting into substrate materials above the ceiling.

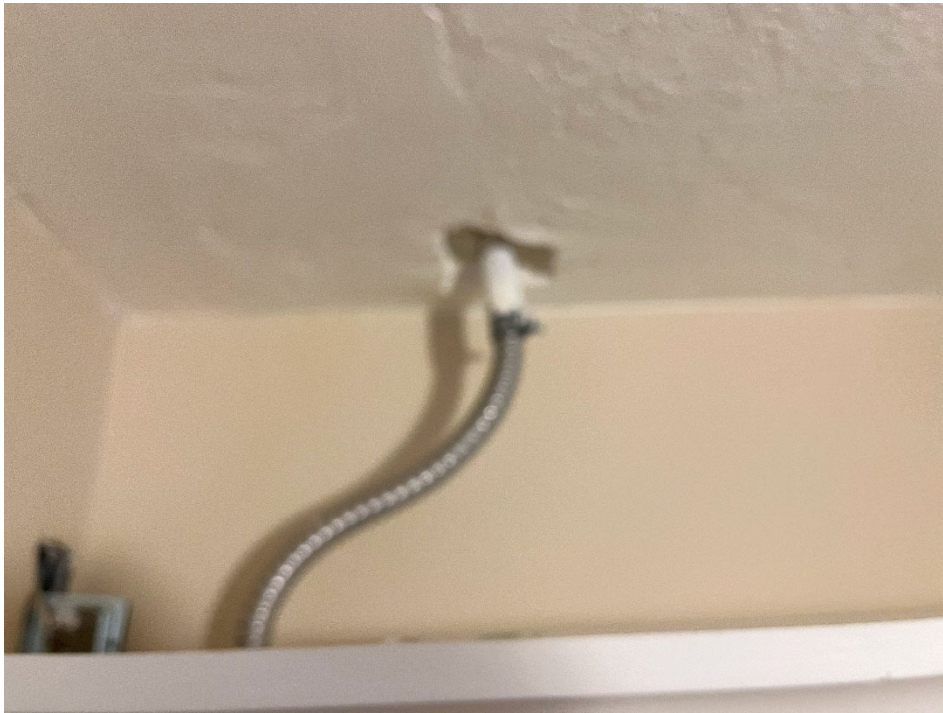
Unit 208 had a hole in the ceiling of the kitchen where what looked to be an electrical conduit was coming out. This ceiling is part of the fire separation from the unit above so its integrity is important especially over the kitchen where the majority of home fires start. Inspector suggests this gap around the conduit be filled with fire resistant mortar or fire sealant to maintain the minimum one-hour rated fire separation at the ceiling of this unit.

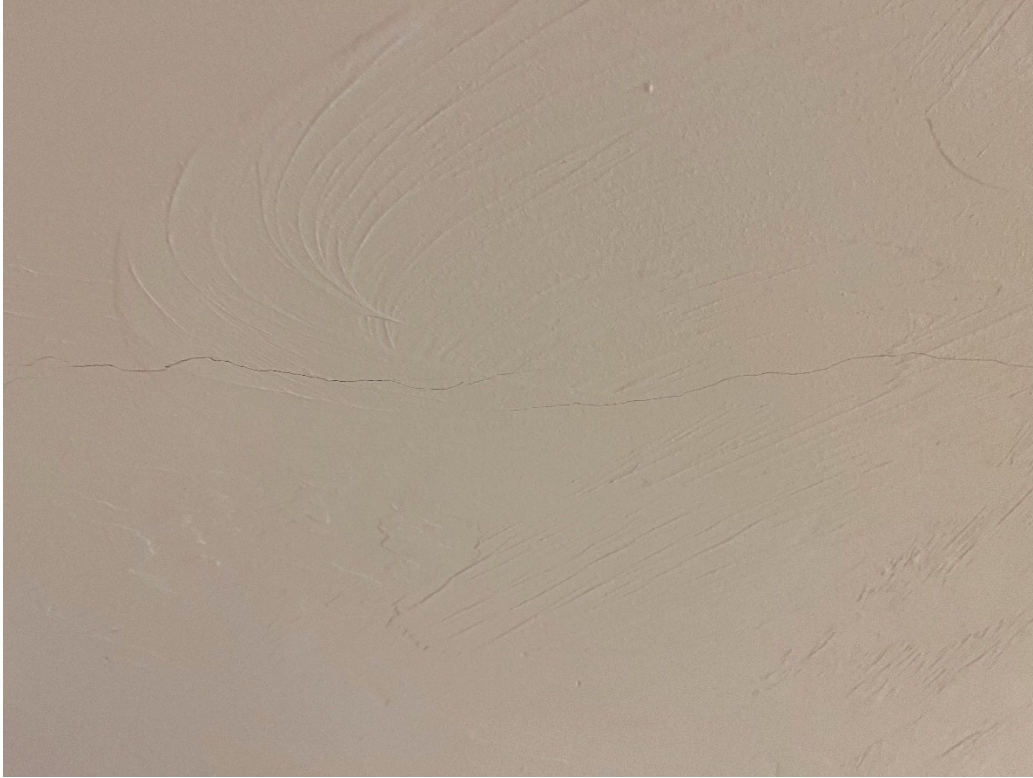
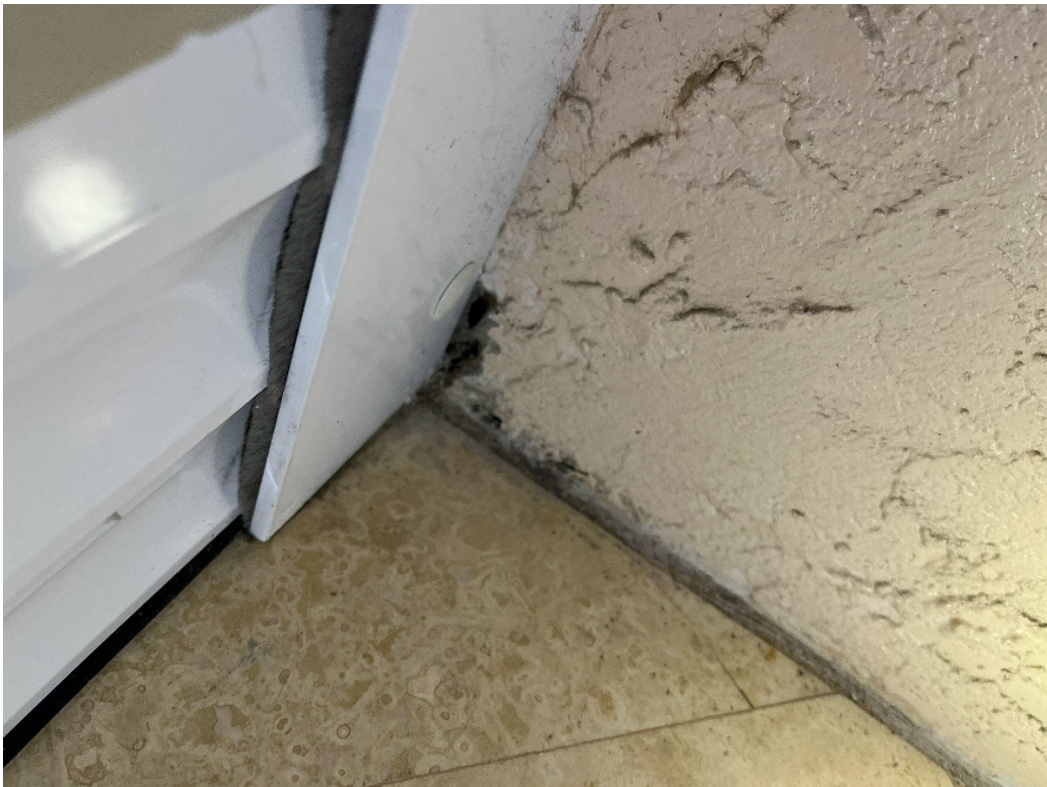
Unit 306 had a hairline crack on the ceiling of the guest bedroom. This is just cosmetic but needs to be repaired and monitored to see if the crack tries to reappear. Also, the Lanai had a hole in the stucco on the right side near the bottom of the hurricane shutter. Since this hole is so close to the outside, it needs to be filled to prevent moisture from getting into substrate materials

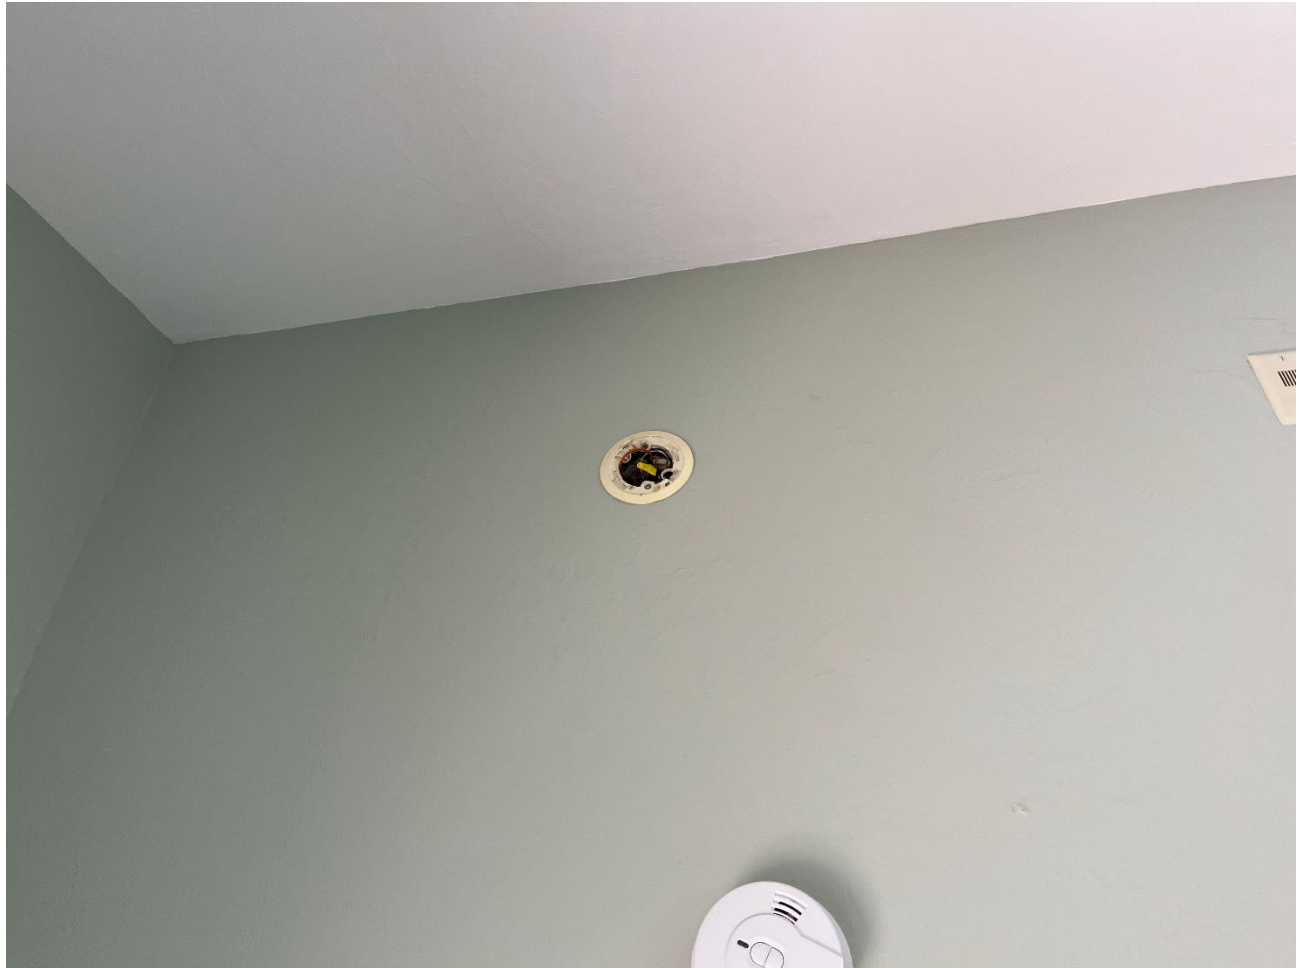
Unit 401 had a cover missing over a junction box in the living room. Covers are needed for safety over junctions in electrical wiring. Replace the cover in a code approved manner.

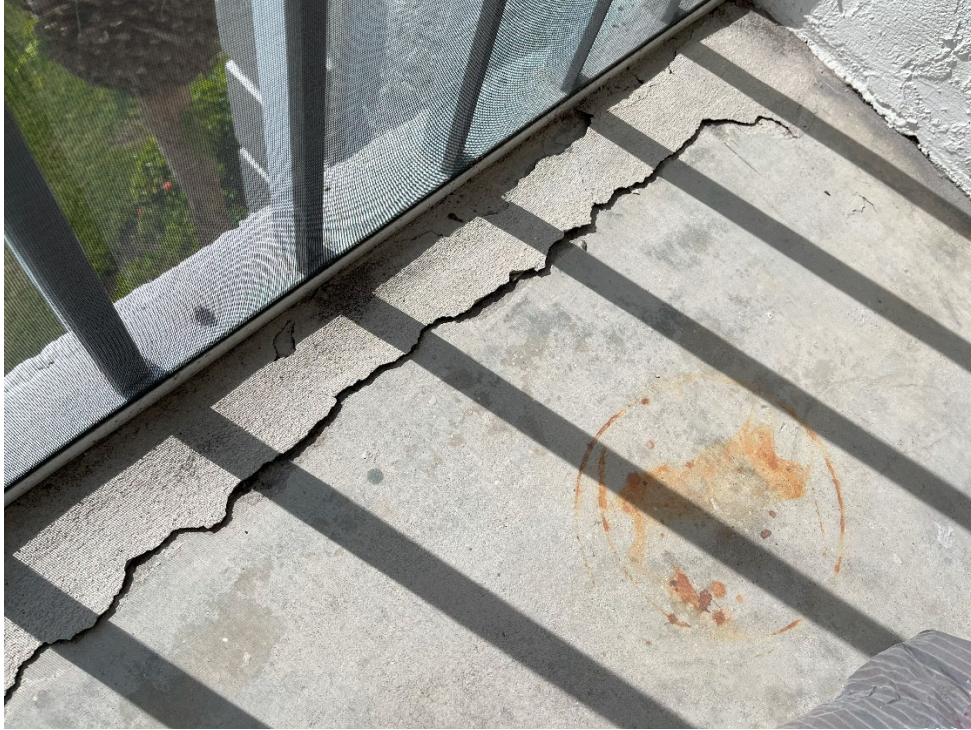
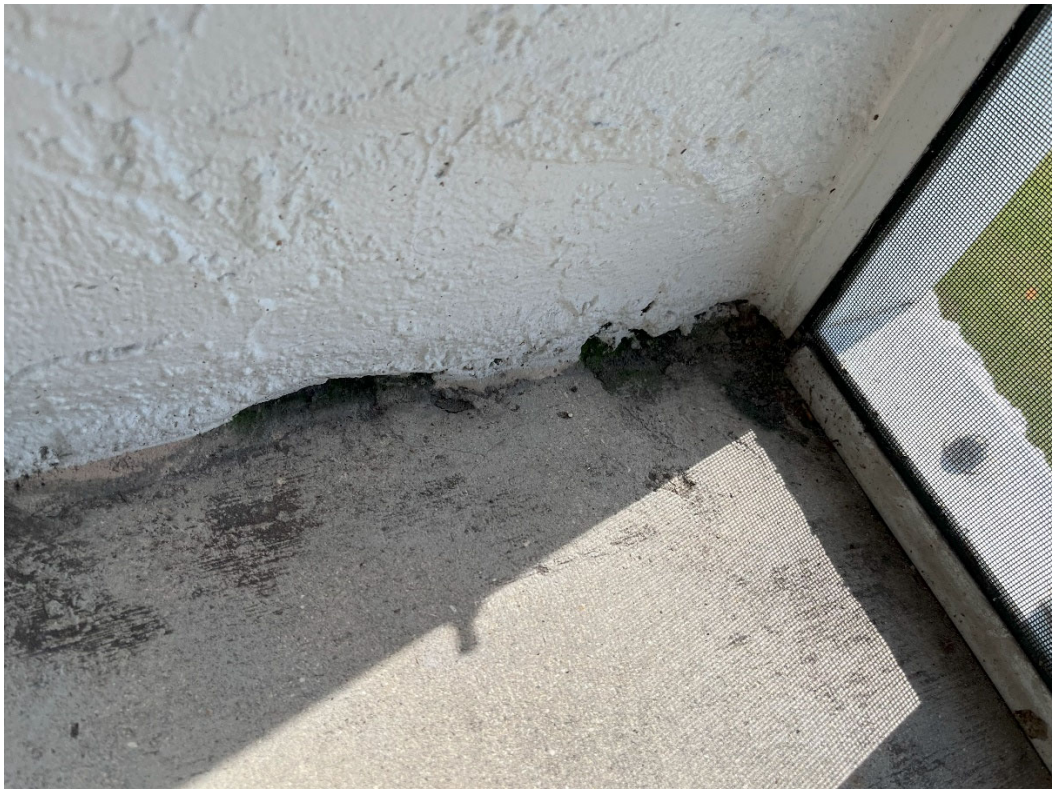
Unit 404 had a significant crack in the floor of the lanai near the balcony railing. It appears to be only be in a skim coat over the structural slab but could be a conduit for water to soak into the supporting concrete slab. Suggest having this crack repaired to maintain the watertightness of the surface treatment. Also there was a gap in the stucco near the floor that needed to be filled.

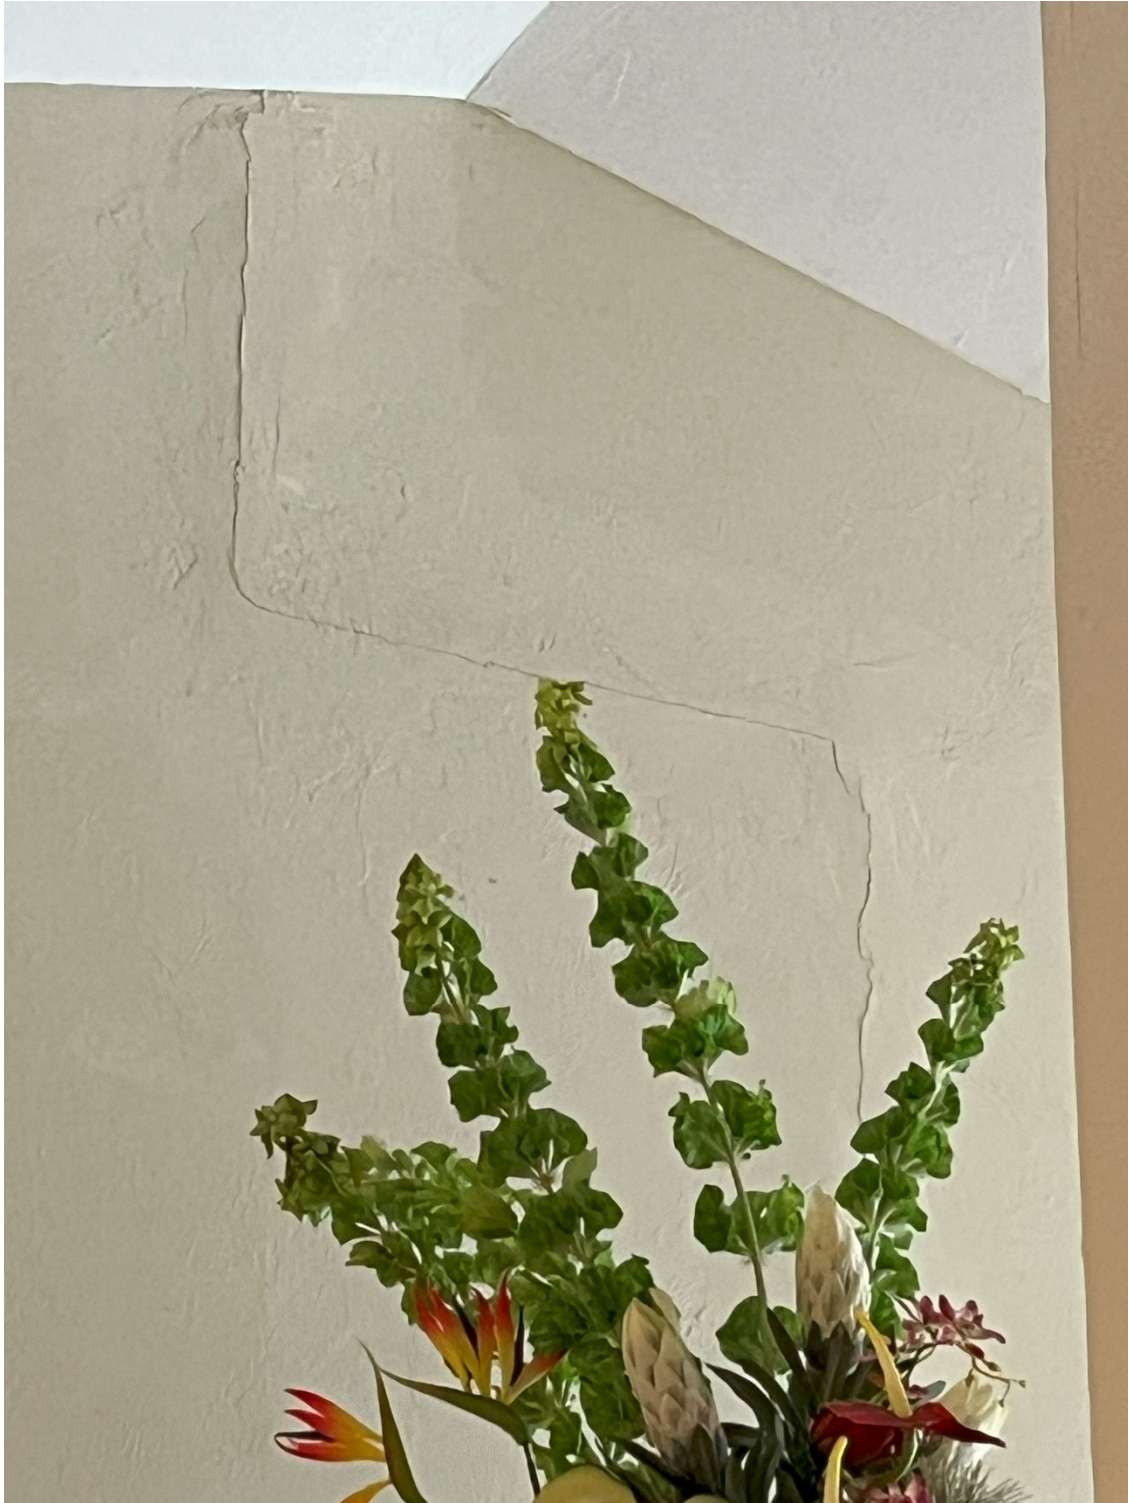
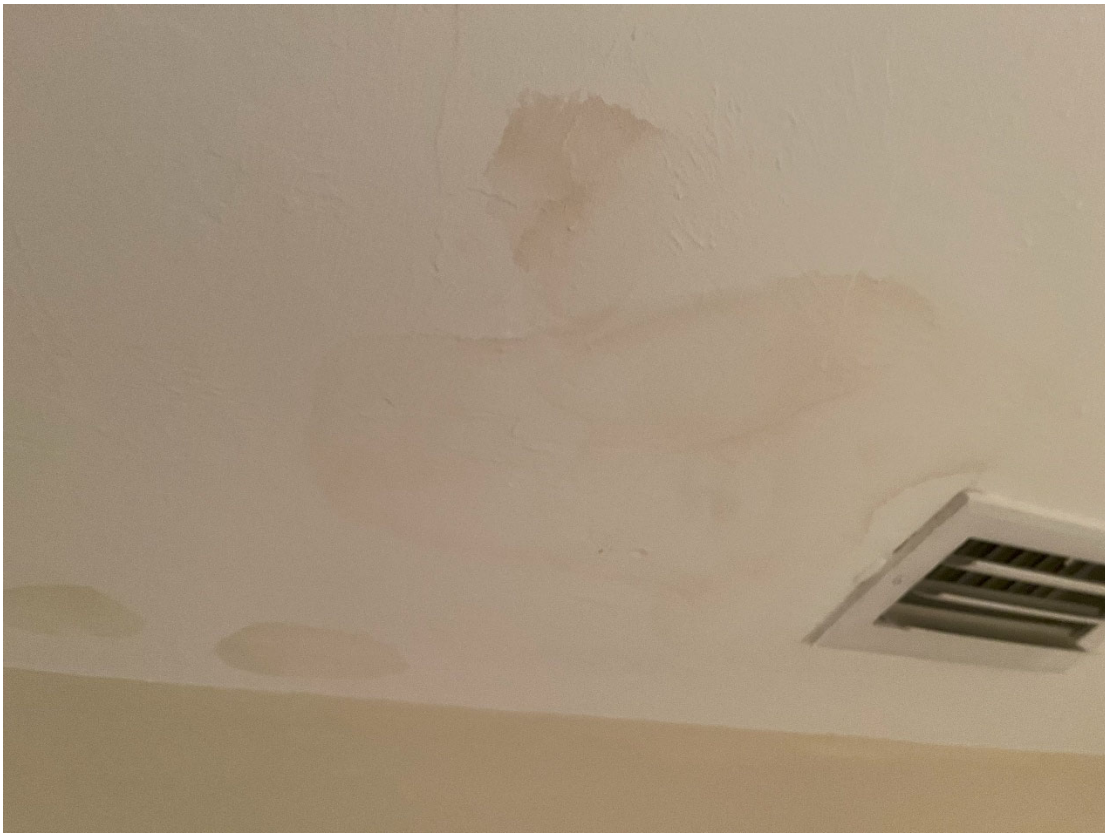
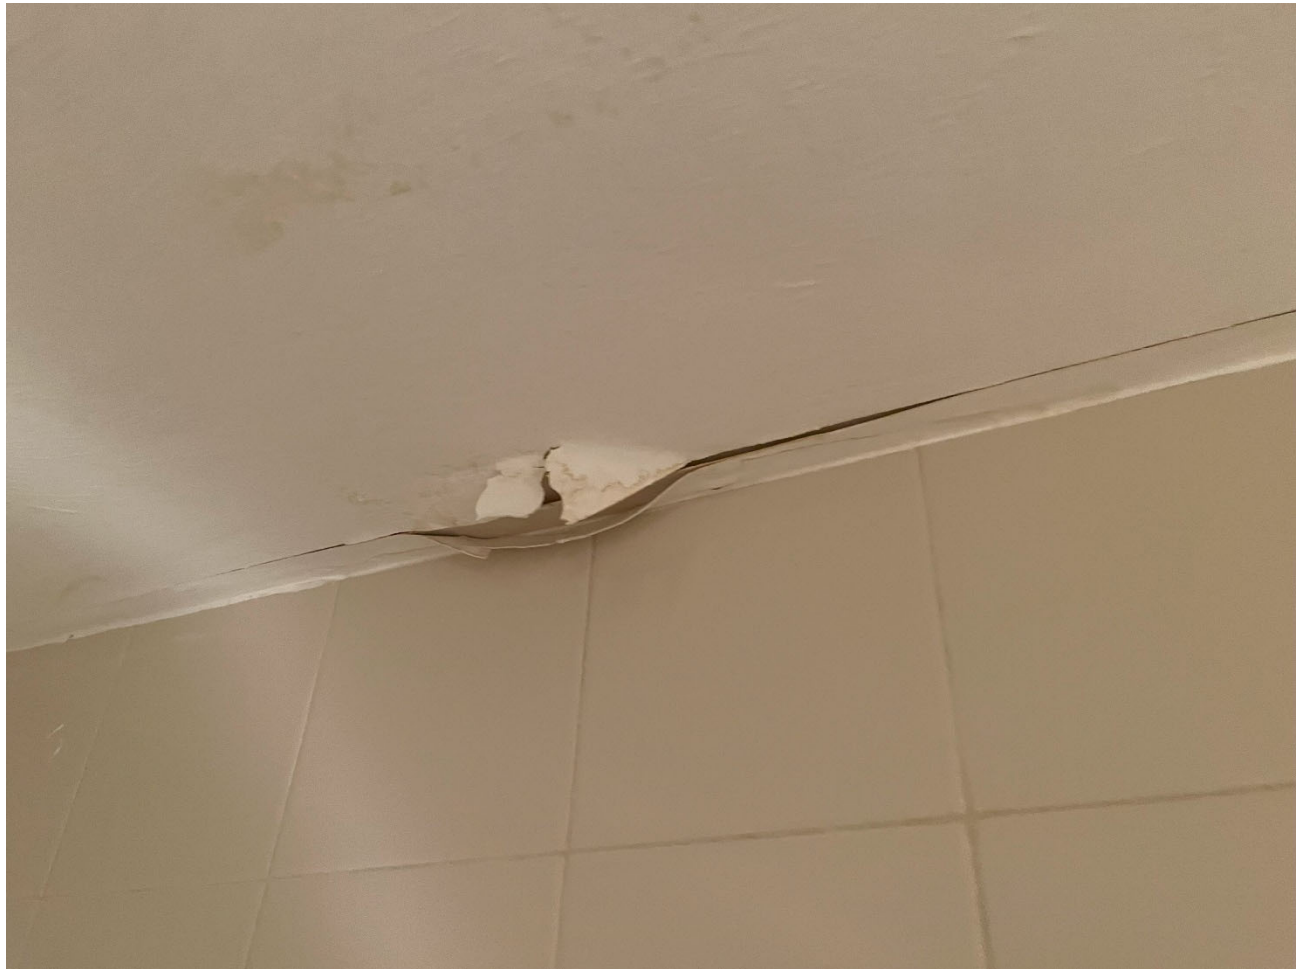
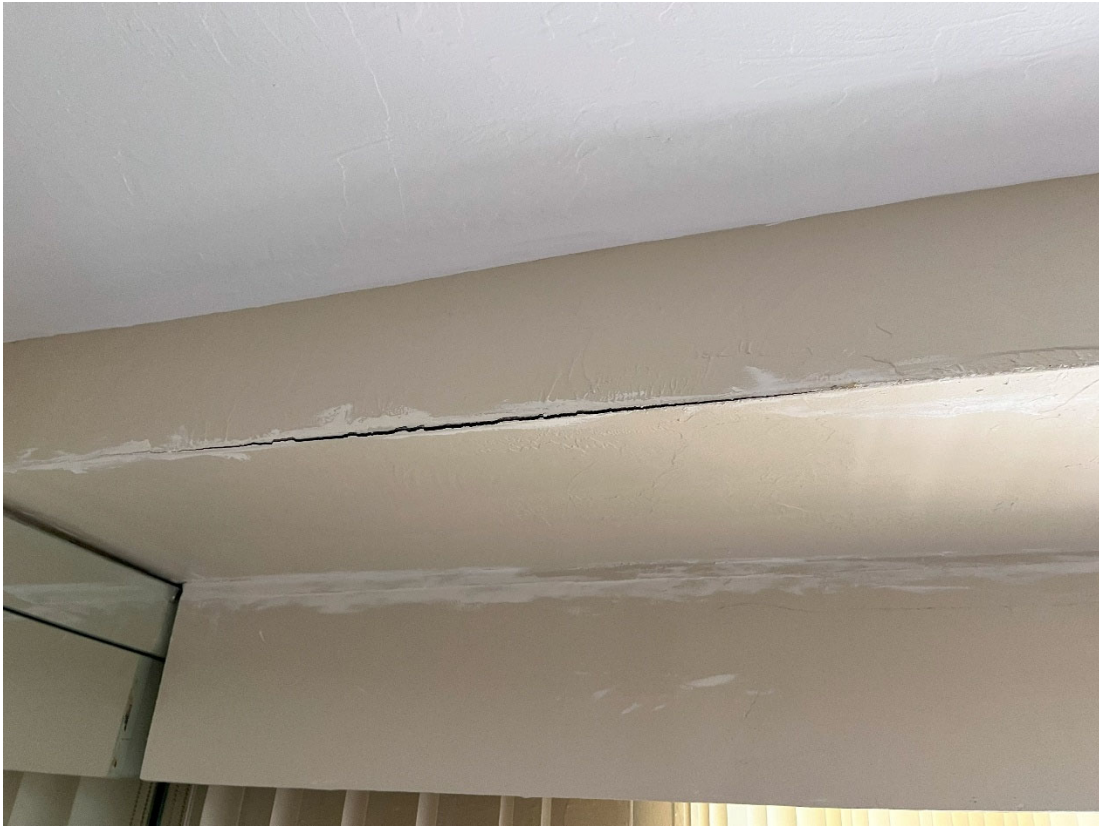
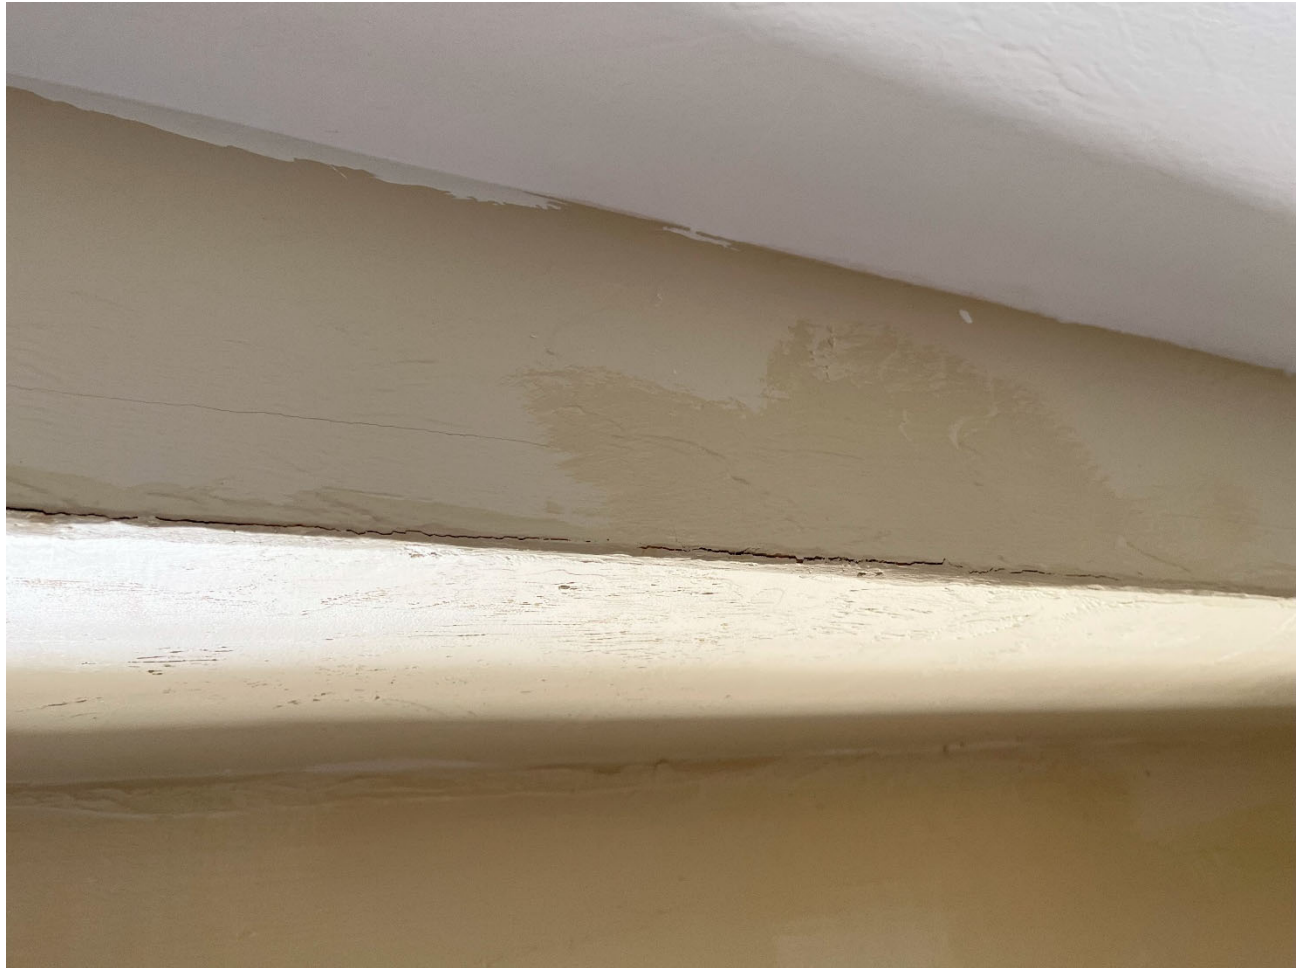
Unit 503

This unit had an S shaped crack in the wall that was unusual. Suggest having this crack repaired and monitored for any changes after repair. There is also some water stains on the ceiling of the master bath. The source of these stains need to be determined but were most likely due to roof leaks that have now been repaired. Paint over these stains and assure they are no longer active. Some cracks appeared to be in the process of being repaired. Suggest having all these completed and assure that they are cosmetic in nature.

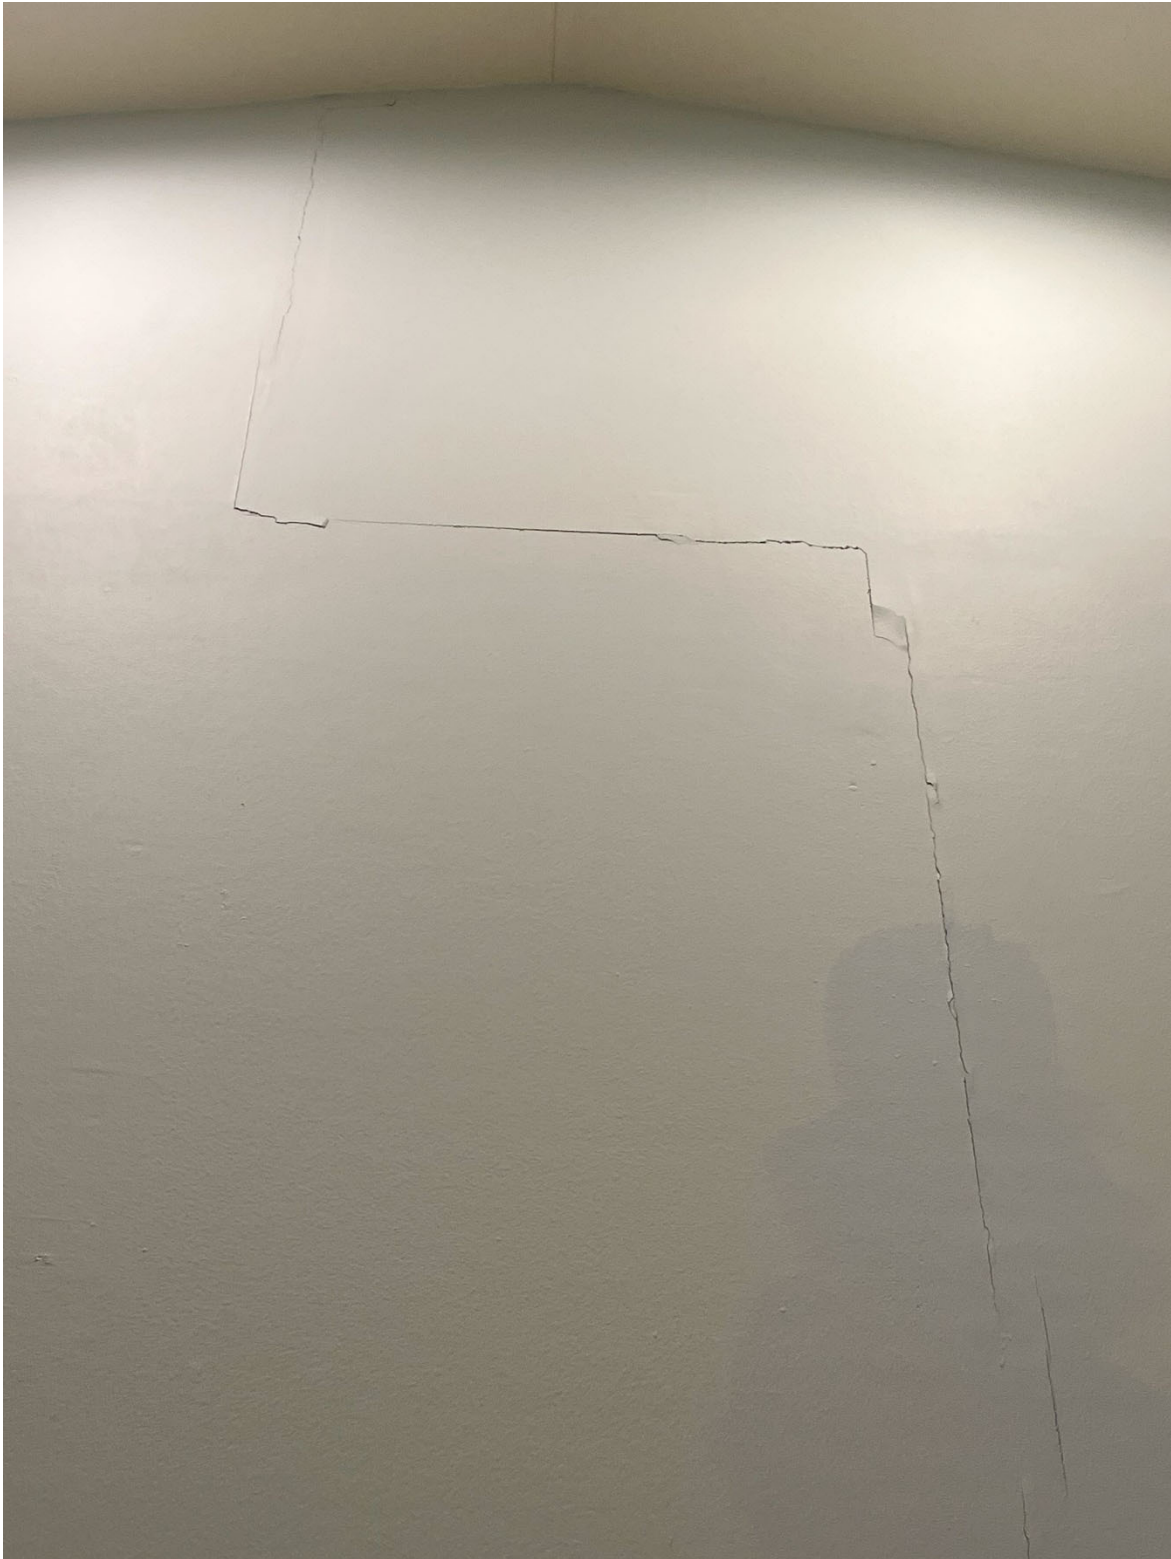
Unit 504

S shaped crack over sinks in Master Bath need to be repaired. Monitor them after repair to see if they attempt to reappear. Repair any anomalies as well in Master Bedroom ceiling close to bath.

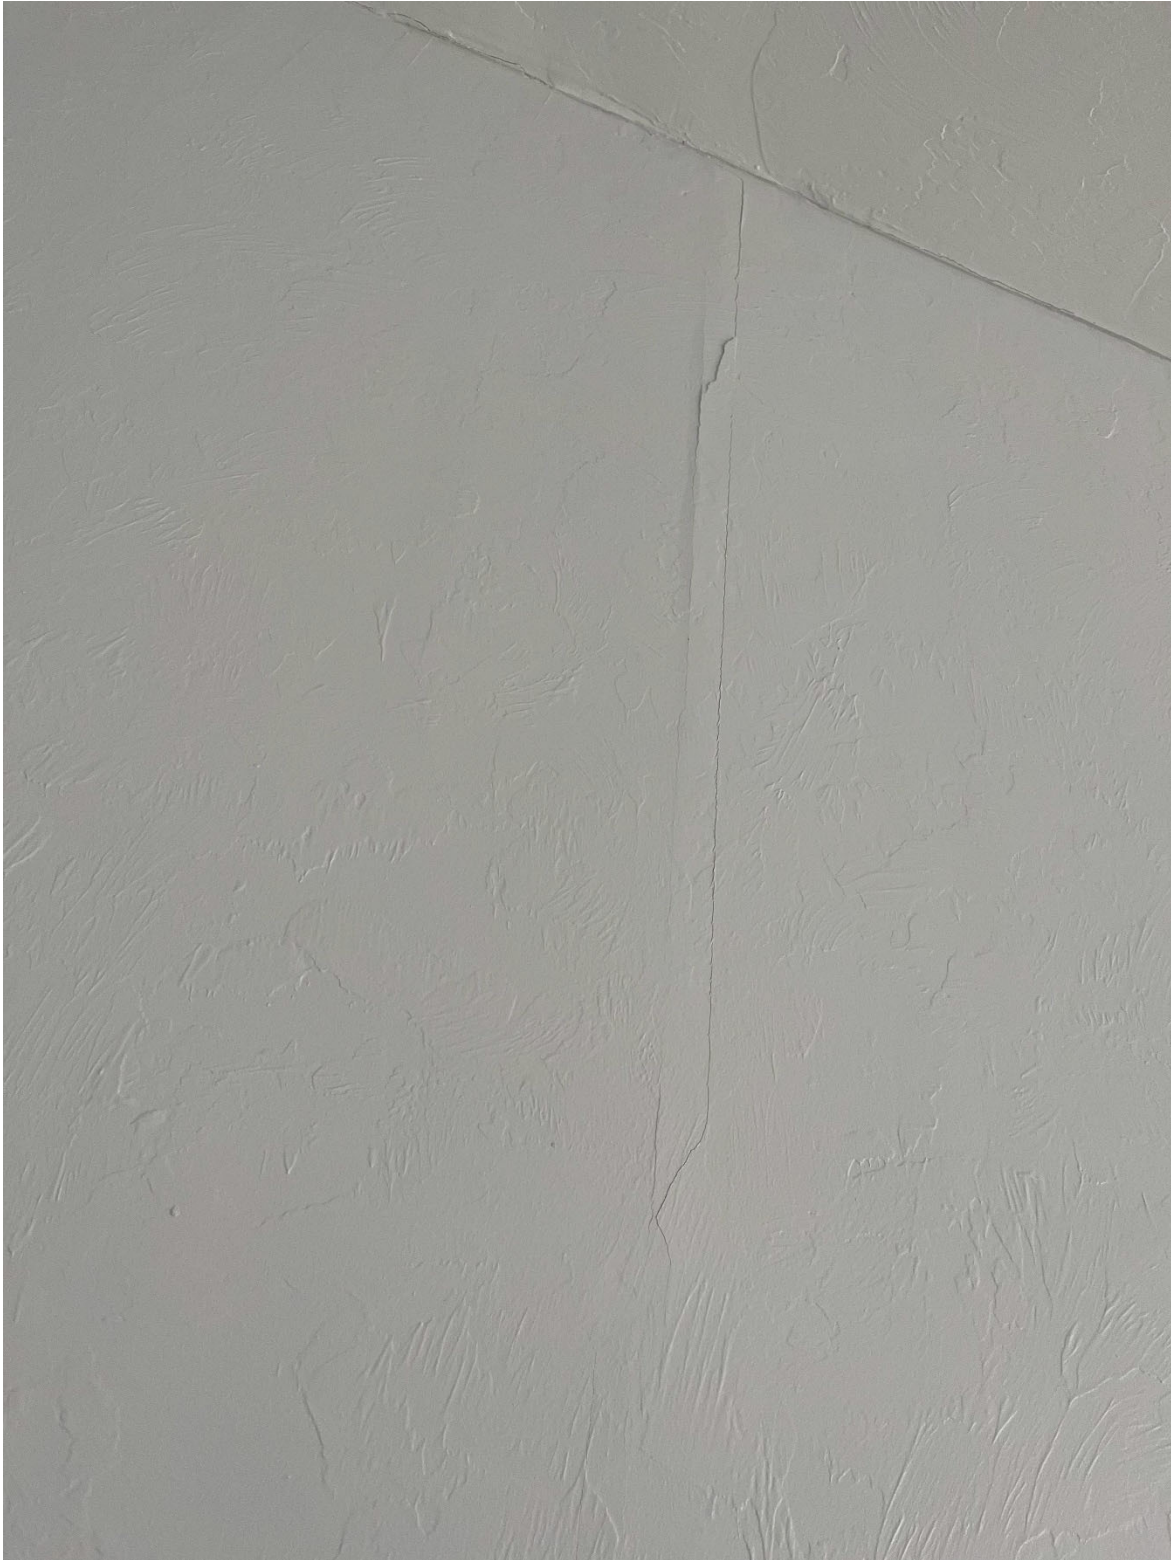
Unit 505

Crack on Living Room wall needs to be repaired and monitored for any future changes.

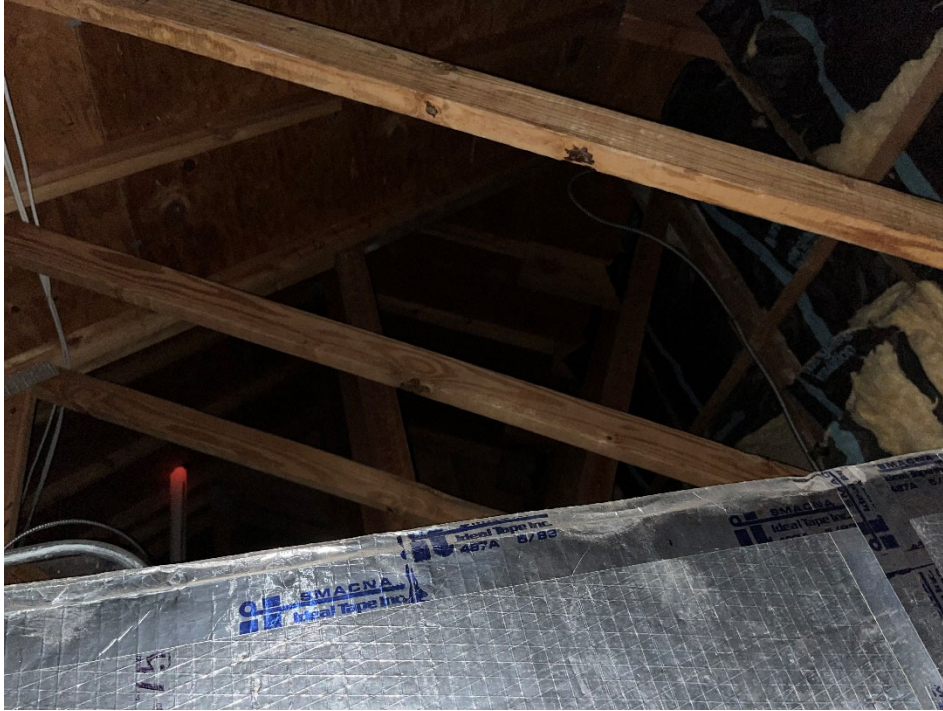
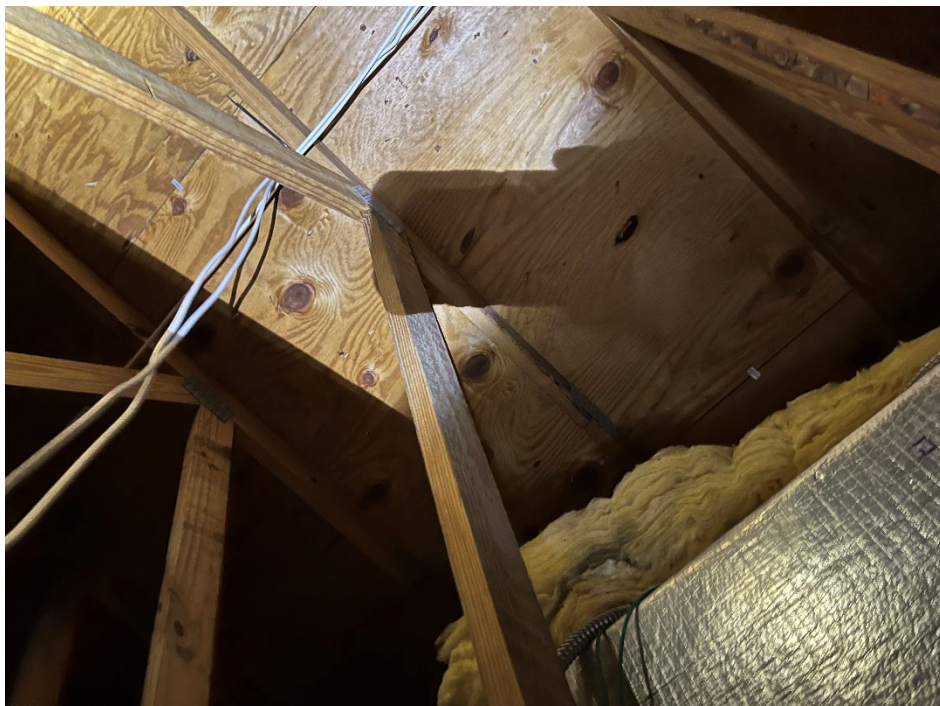
Typical Roof Framing Components

The attic was entered to assess the roof framing. Framing consisted of pre-engineered wood trusses. All appeared to be in good condition with no anomalies apparent. Required hurricane clips and tie downs were observed in place and functional. The access panel that was used did not have any insulation on top of it. Inspector recommends gluing a solid block of EPS (Styrofoam) to the top of the all the wood access panels to make them more energy efficient.

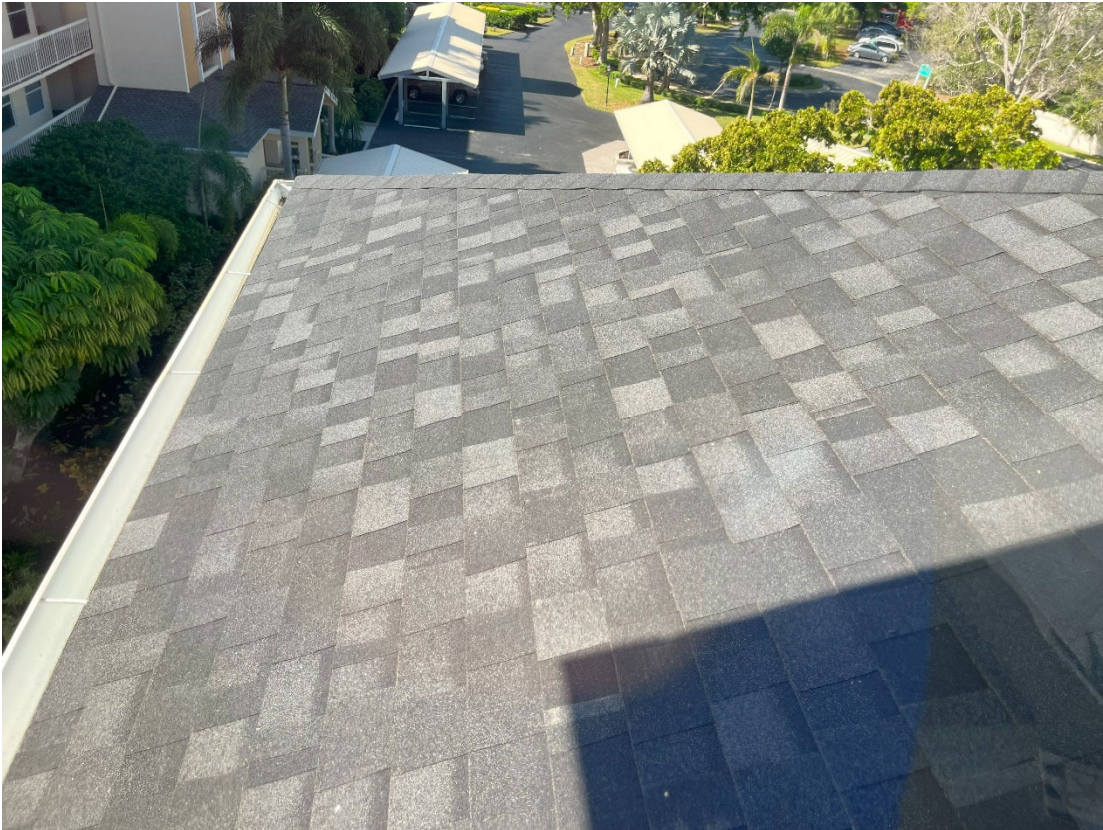
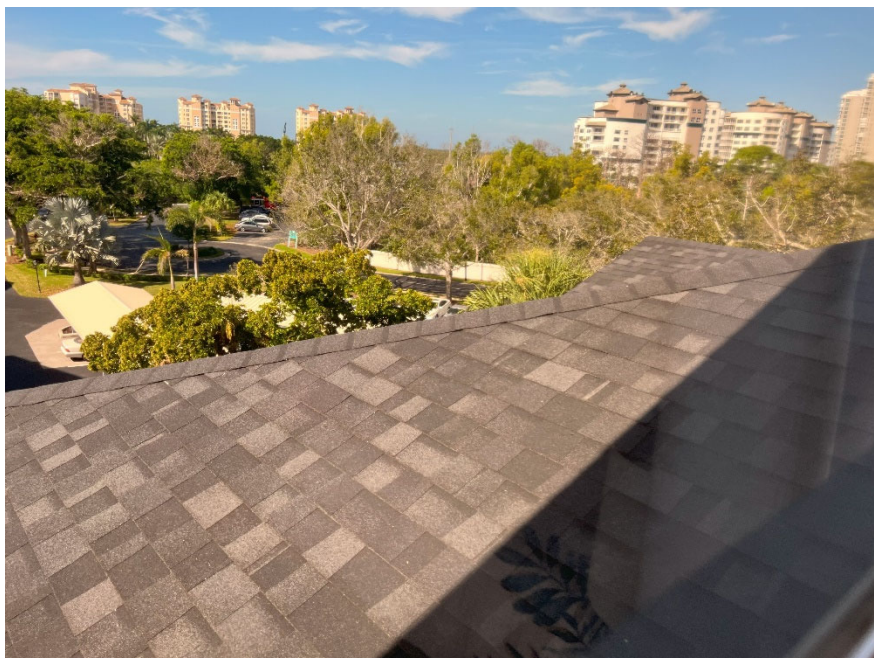
The dimensional fiberglass composition roof on this building was in excellent condition. Property Manager said the roof had been replaced recently. Roof was evaluated from the ground and from the adjacent balconies or windows but no anomalies were observed. Roof appeared to be in like new condition with a remaining life expectancy exceeding 25 years. Representative photos:
