FLORIDA ENGINEERING LLC

RESIDENTIAL REPORT

340 Horse Creek Dr
Naples, FL 34110

MAY 5, 2025

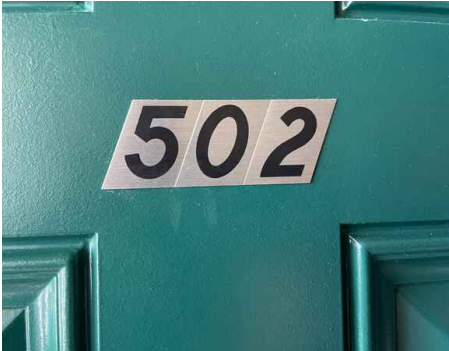
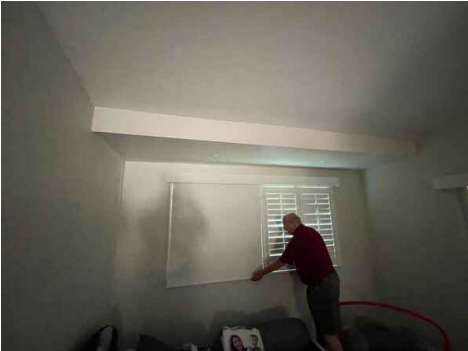
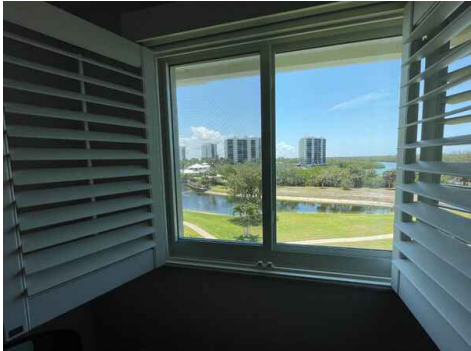
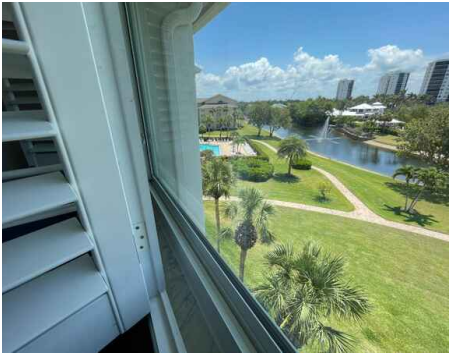
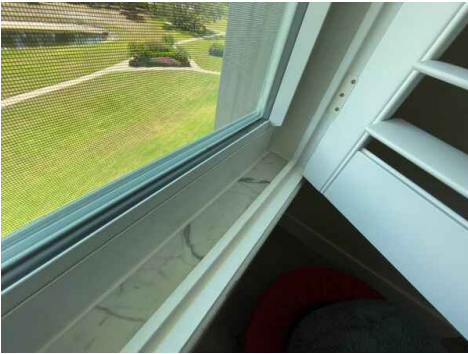
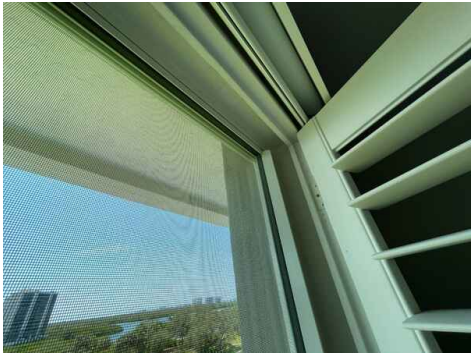
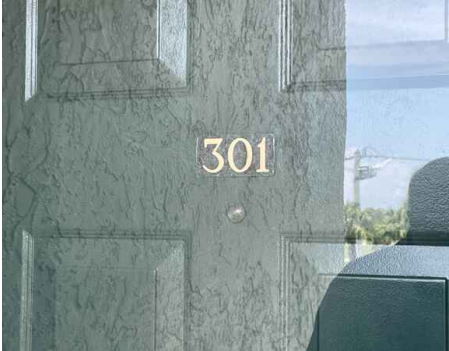
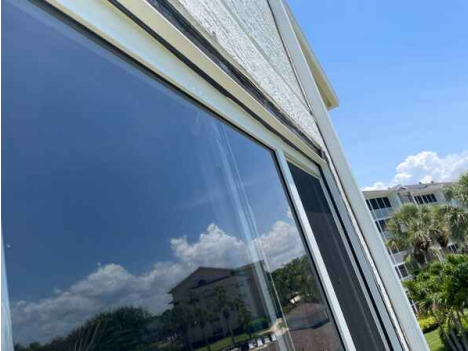
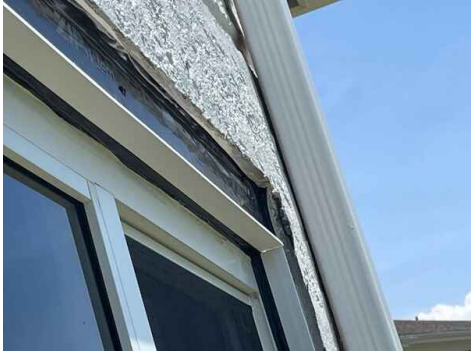
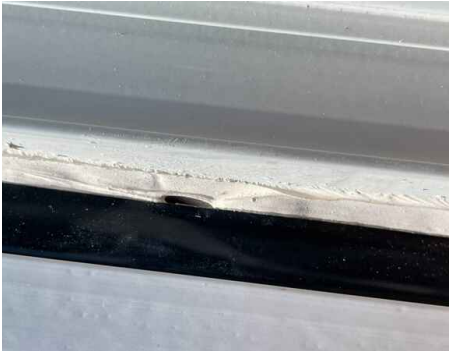
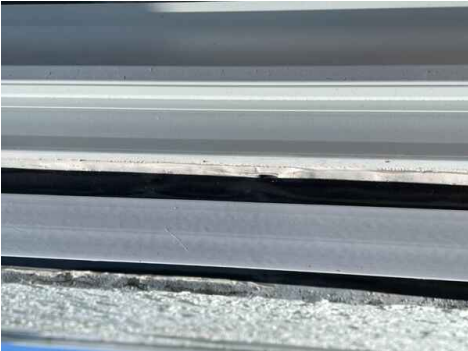
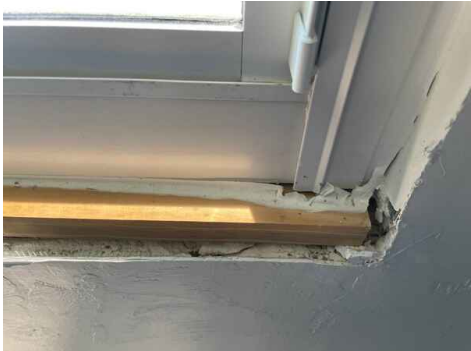
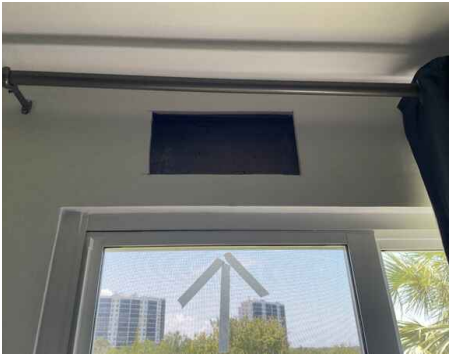
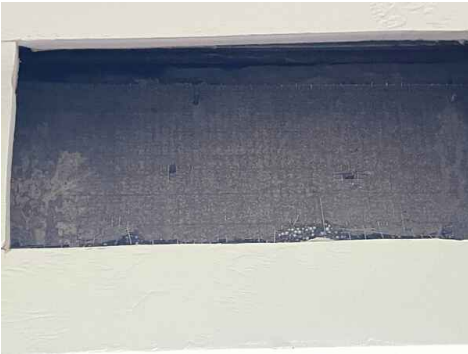
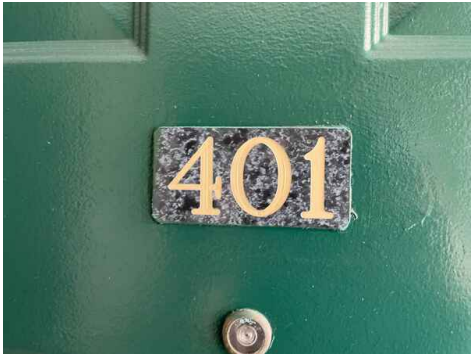
Inspection Photos

The back exterior walls are experiencing various stucco cracks and water intrusion especially around the windows. As a result, the exterior plywood sheathing, the interior insulation and dry walls, along with the metal studs and fascia are experiencing severe deterioration.

The issue is not limited to around the immediate windows area only, it is impacting the entire framing, sheathing and insulation below the windows.

In addition to the back wall observations that some stucco cracks are visible in the back wall areas, there are visible damages to the roof flashings as well. The stucco cracks issues may be resolved with the back wall replacement, however the the roof flashings needs to be repaired/replaced as deemed required.

Given that the HOA is looking into total window replacement of old non-rated windows to Hurricane rated windows, it is recommended to consider removing the interior drywall and insulation to expose the stud wall channels and plywood sheathing from the inside of the room.

- 1) Repair/replace locally in kind
- 2) Replace the entire plywood sheathing with new plywood or dense glass type sheathing (Owner's preference) along with insulation and dry walls after installation of the new windows, in accordance with manufacturer's recommendations.
- 3) Re-apply the exterior stucco and the paint inside.
- 4) FE recommends following the repair/replacement Shown in Attachment-A, included in this report.
