SECTION 1 – INTRODUCTION

PRINCETON PLACE III AT WIGGINS BAY

Site-Visit Date:
October 30, 2023

Report Date:
November 15, 2023

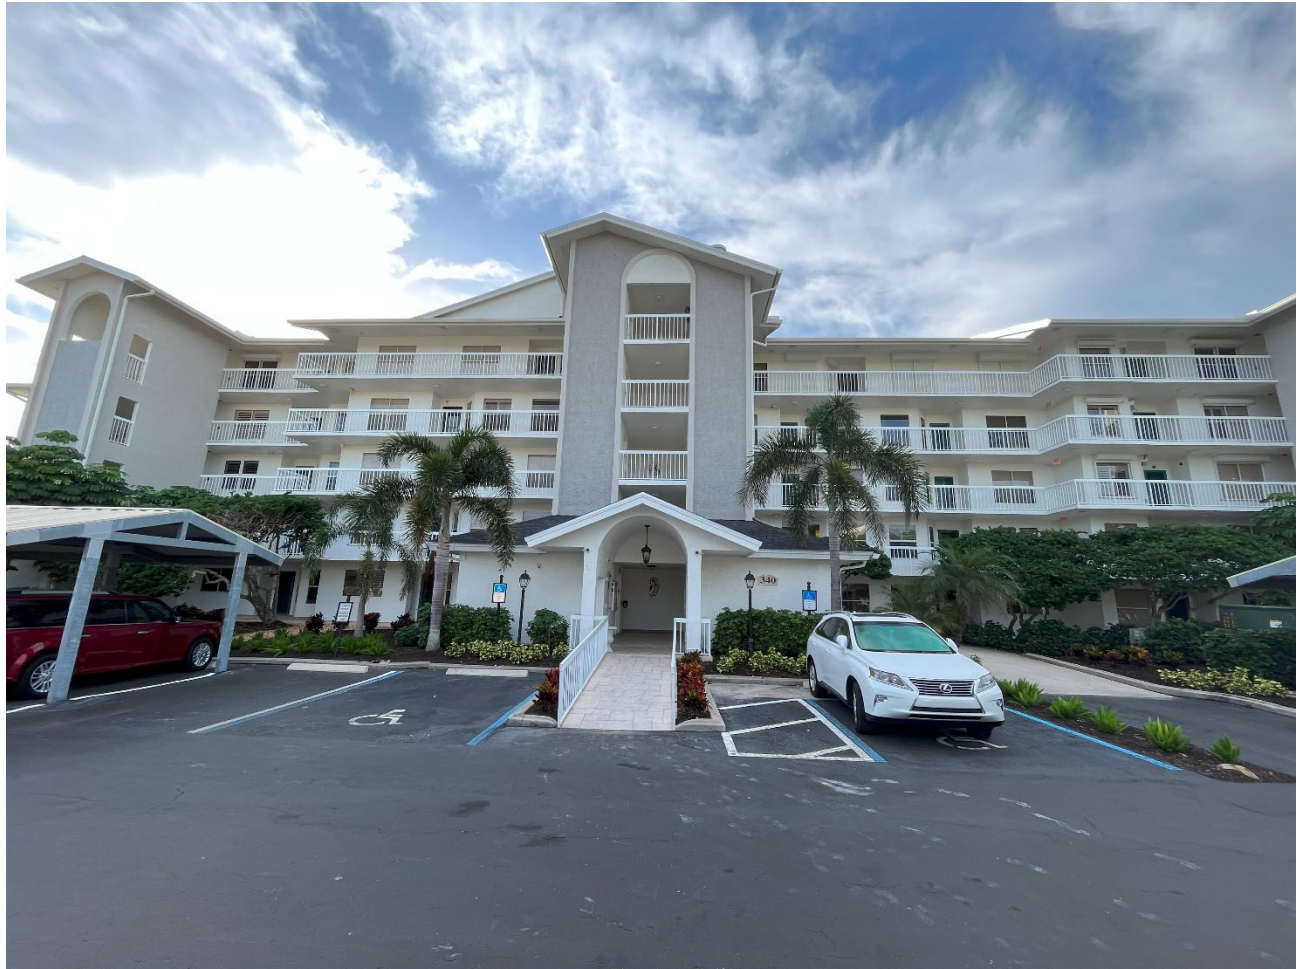
Front View

Princeton Place 3 has an exterior of cementitious stucco. Exterior is generally in good condition with no hairline cracks observed in the stucco. See comments and photos following:
