FLORIDA ENGINEERING LLC

RESIDENTIAL REPORT

340 Horse Creek Dr
Naples, FL 34110

MAY 5, 2025

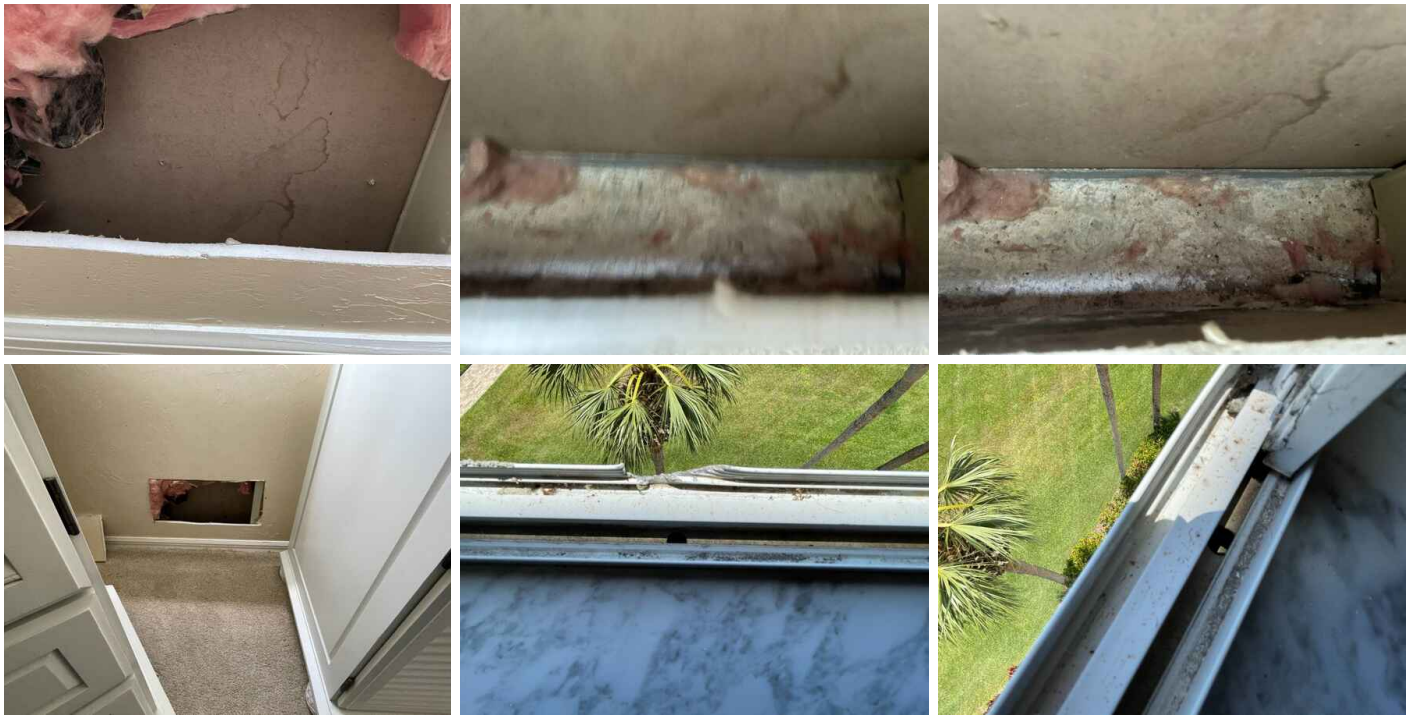
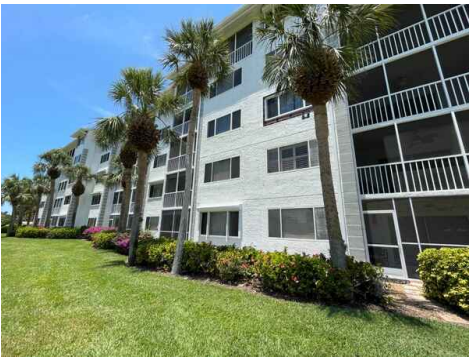
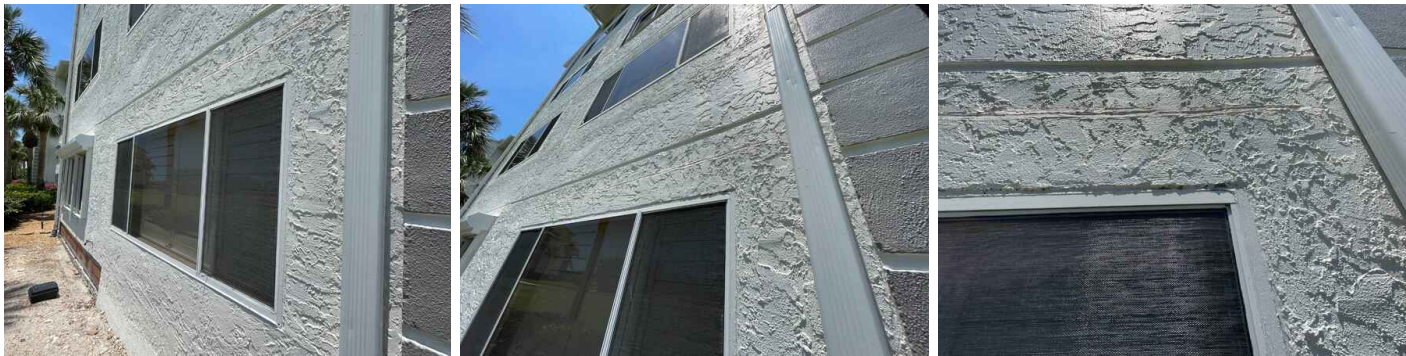
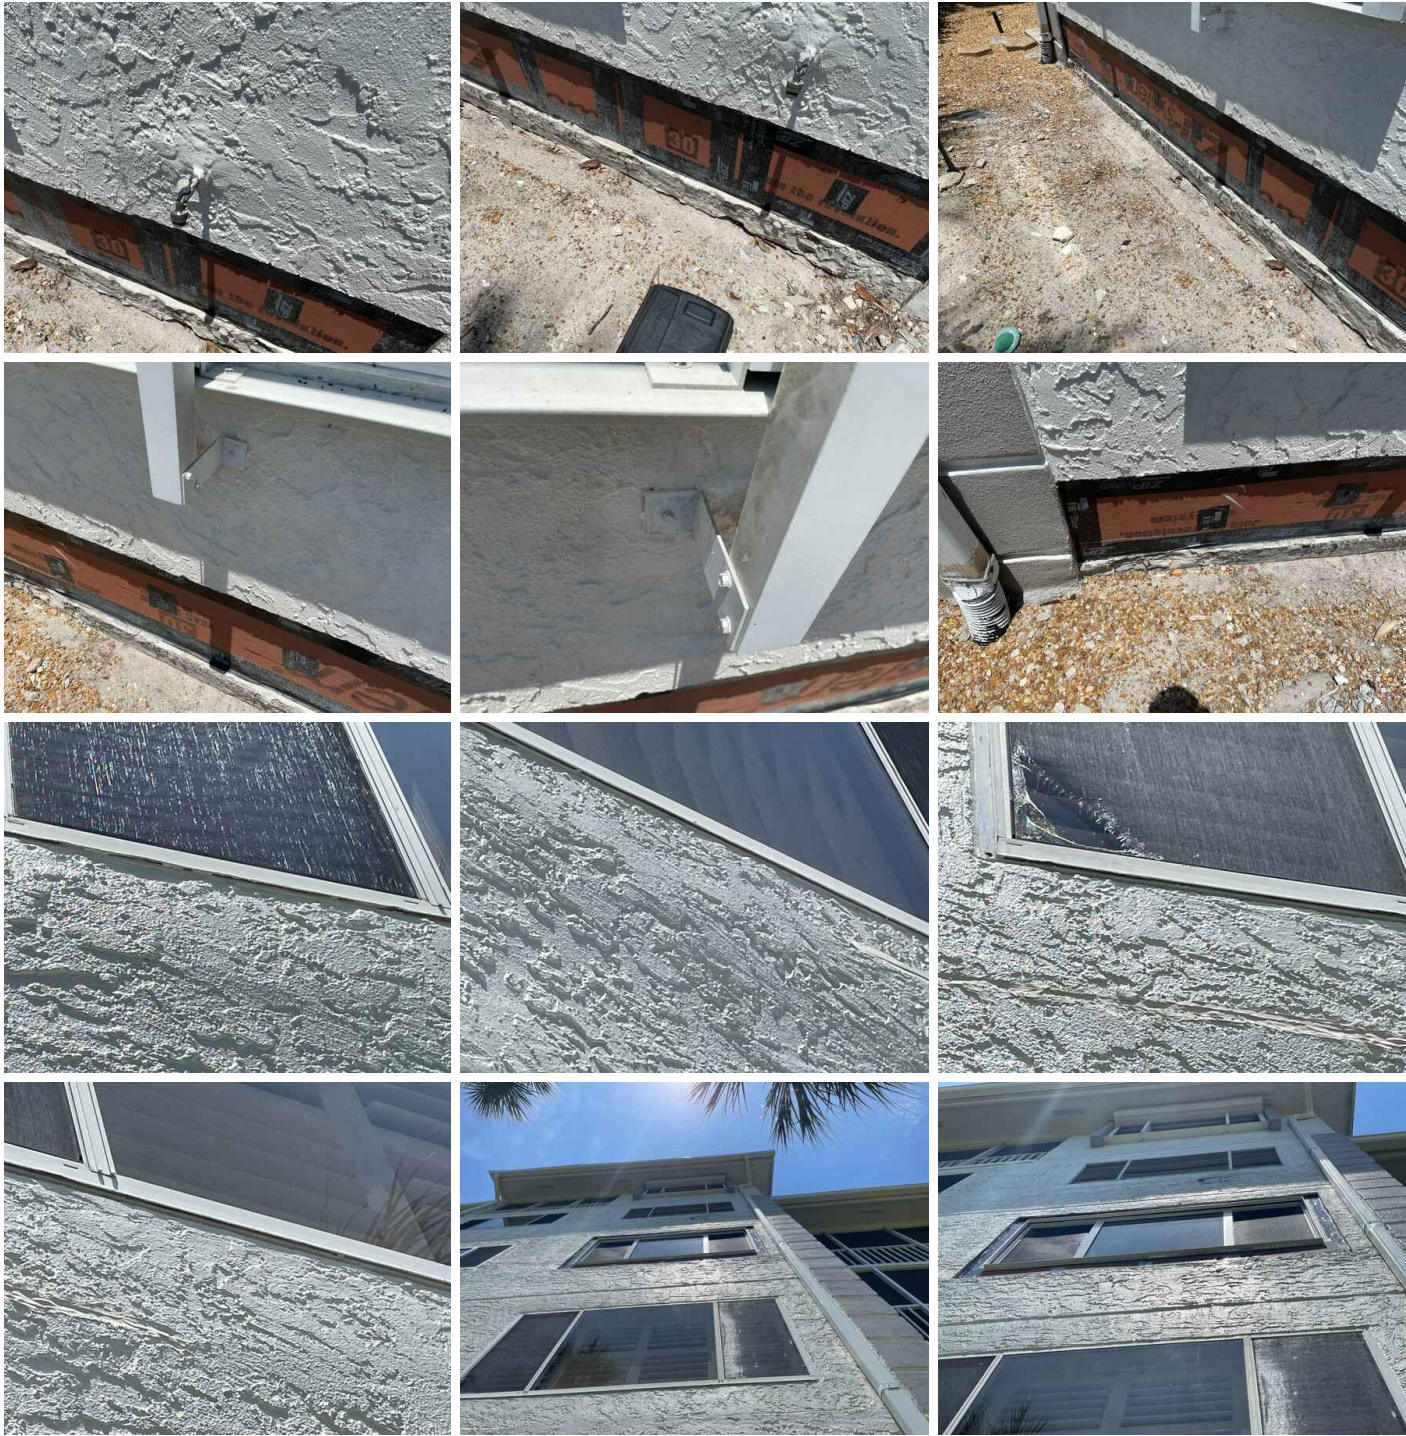
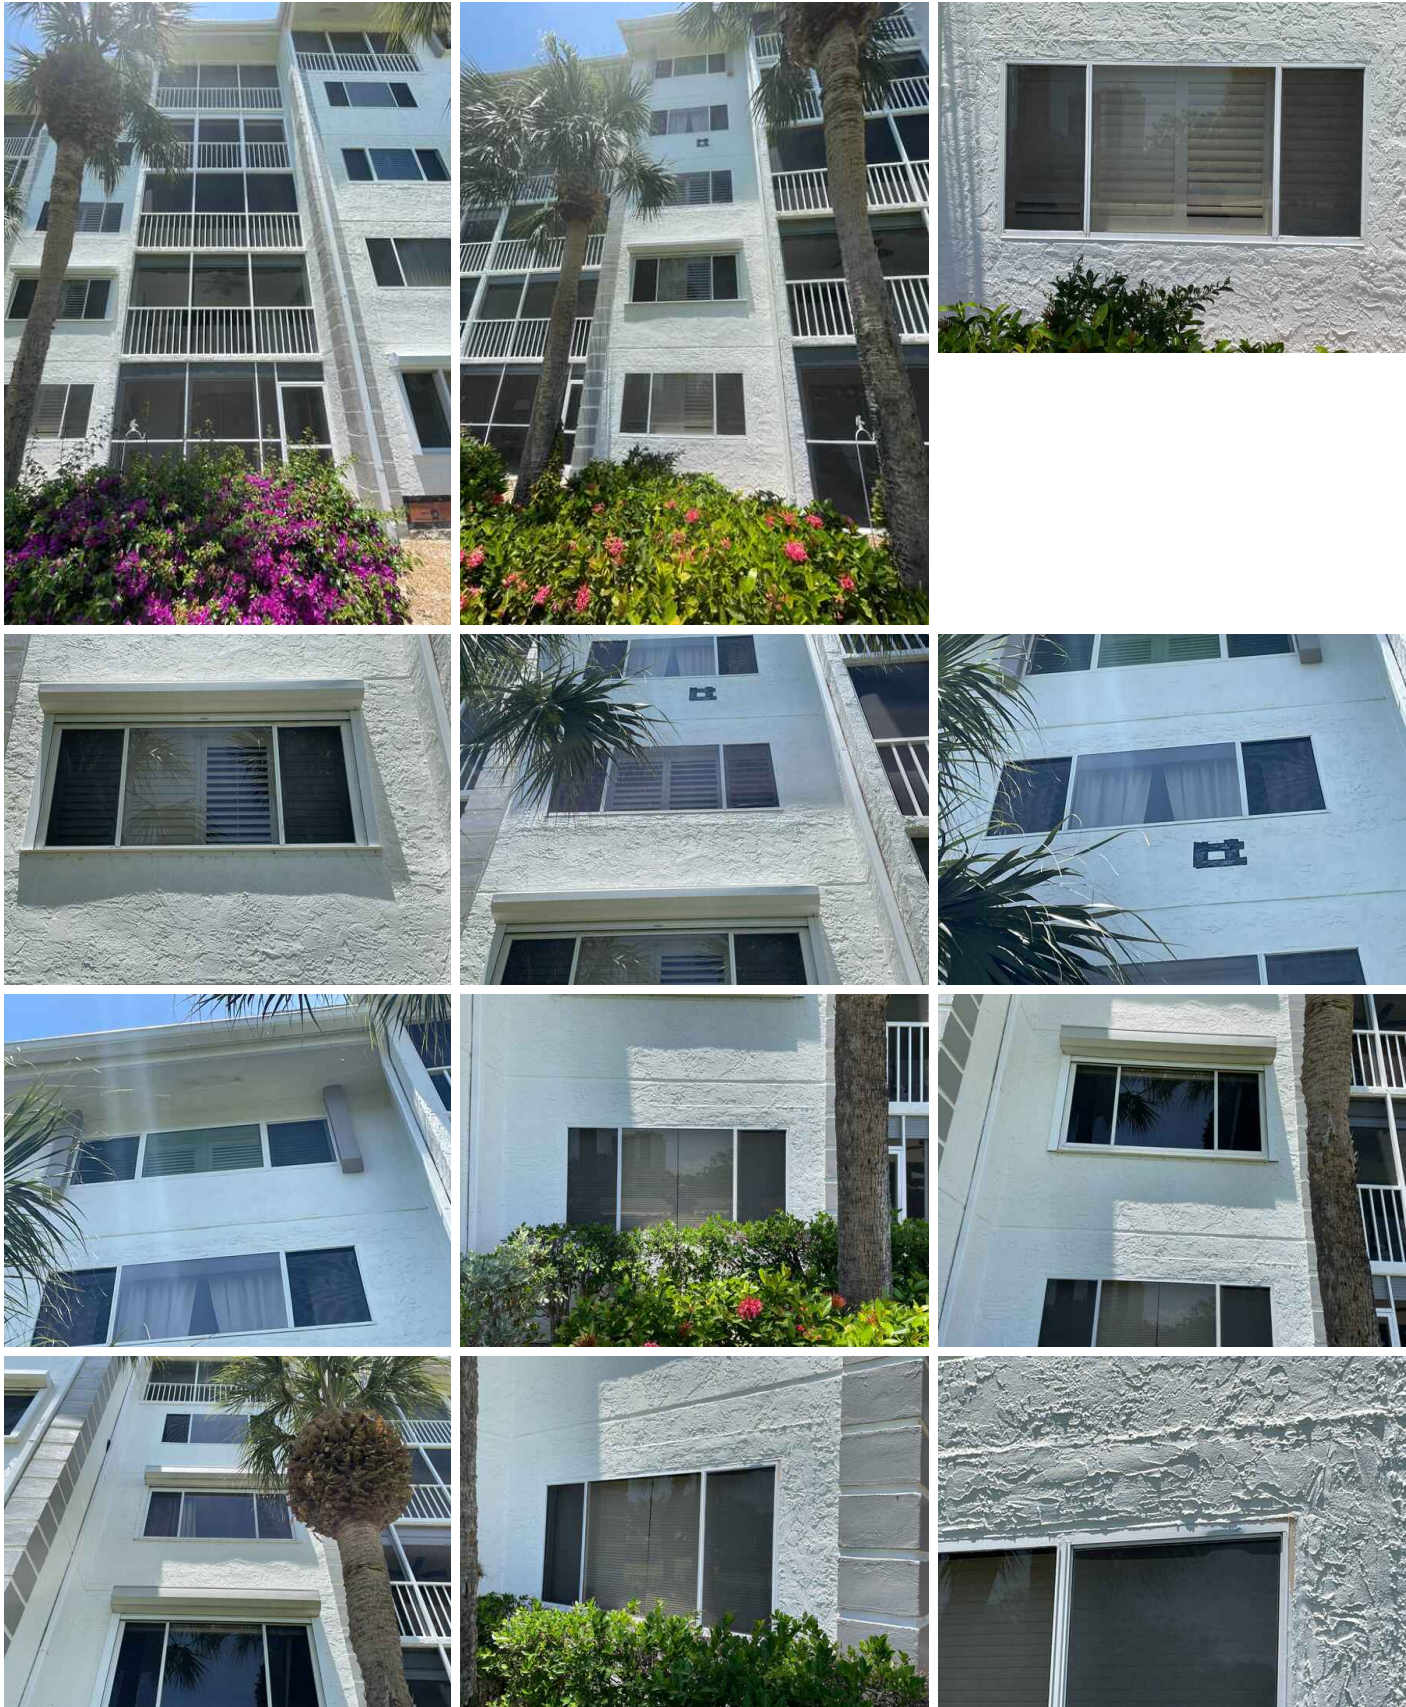
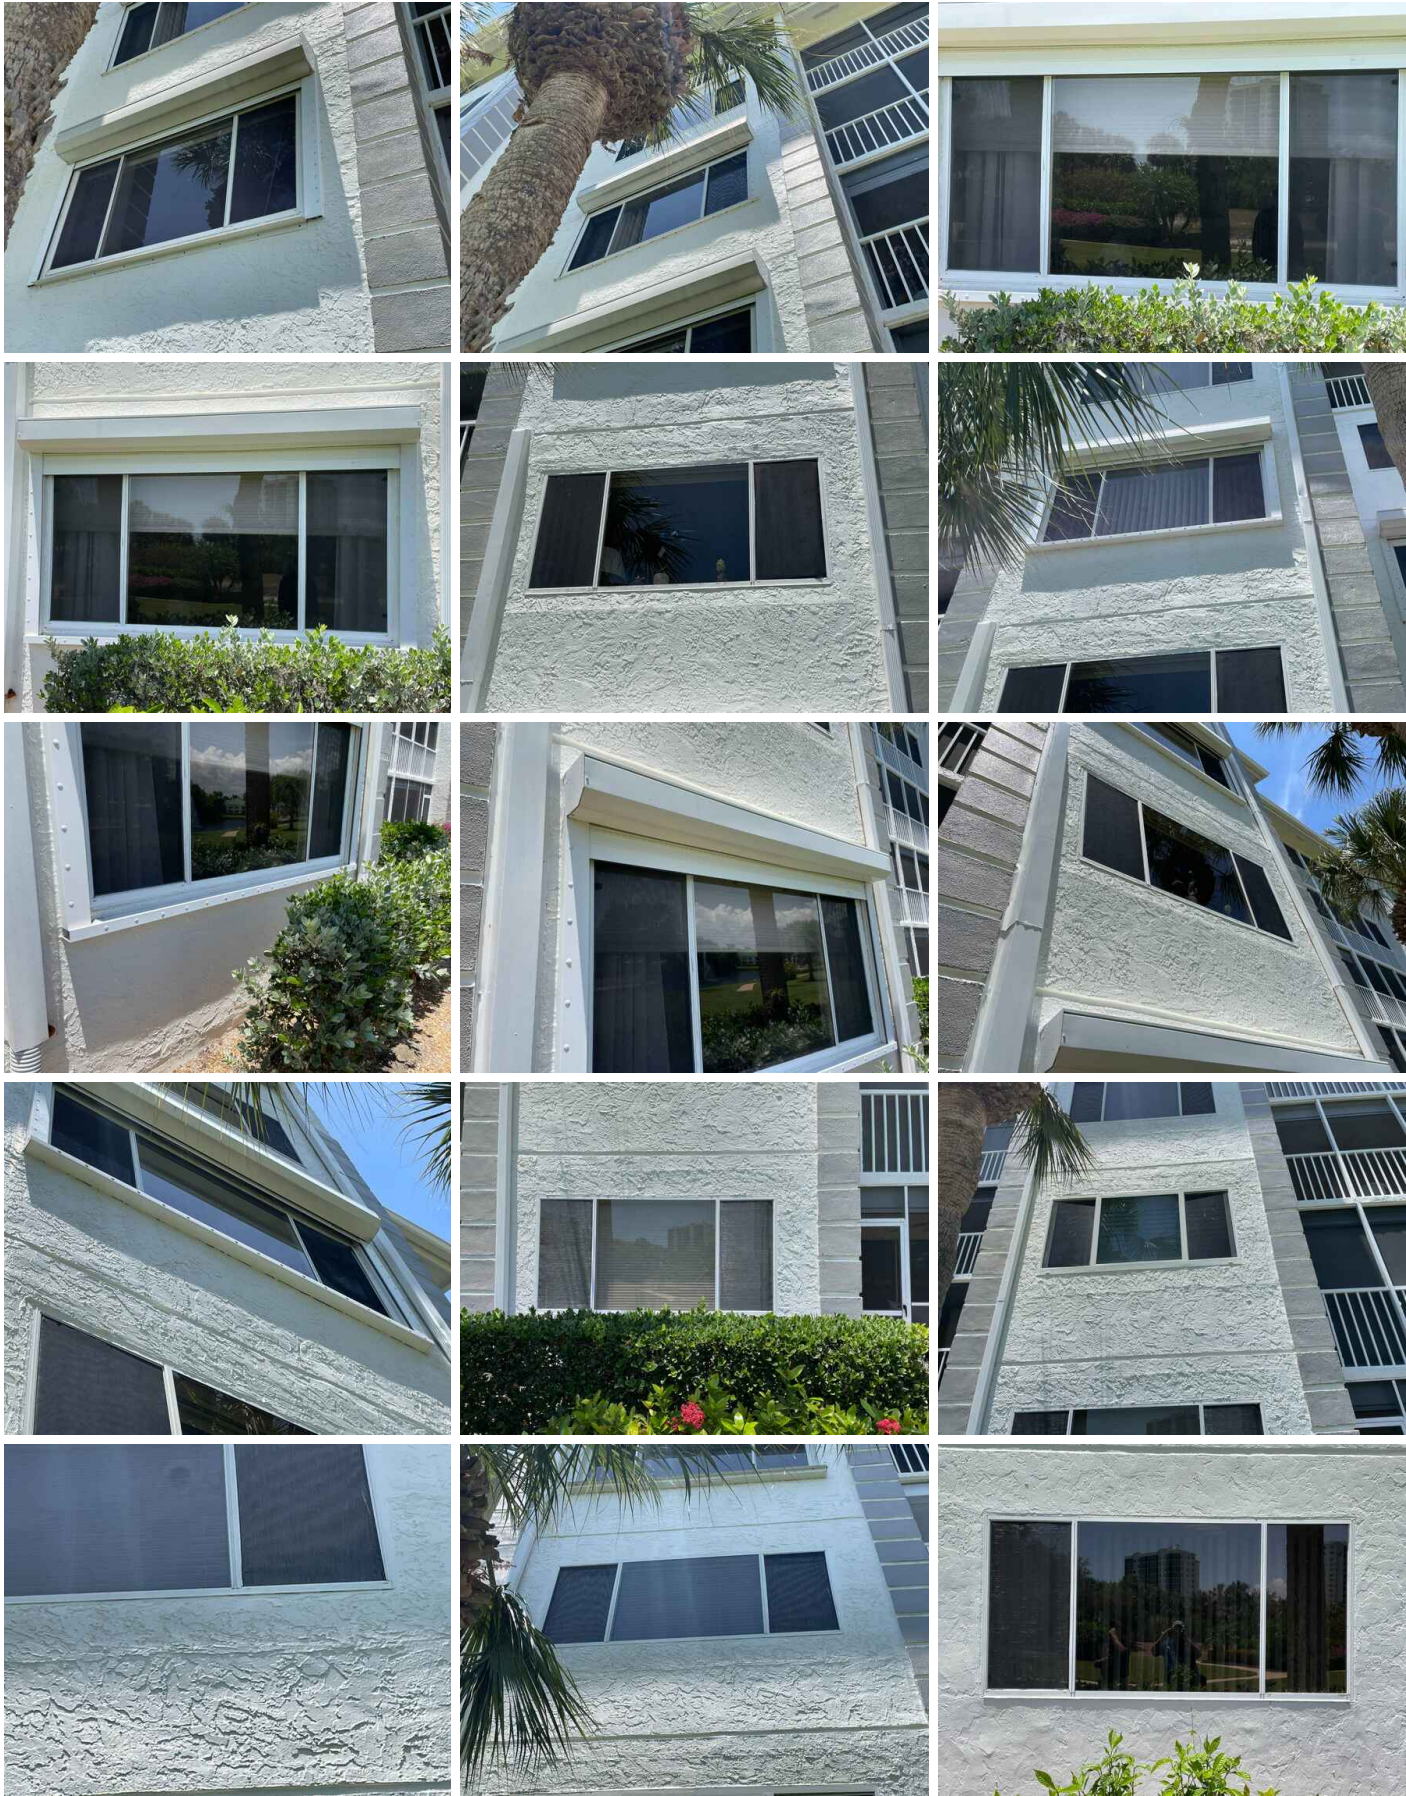
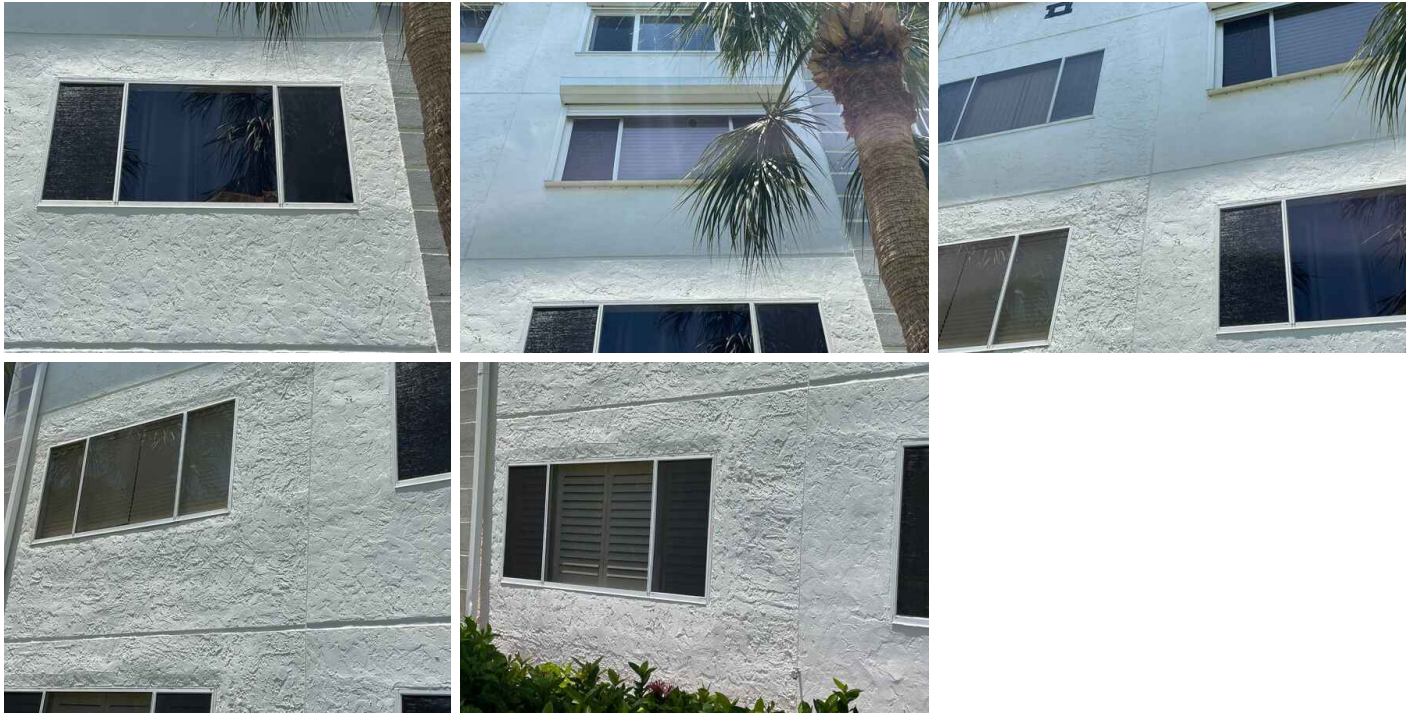
Inspection Photos

The back exterior walls are experiencing various stucco cracks and water intrusion especially around the windows. As a result, the exterior plywood sheathing, the interior insulation and dry walls, along with the metal studs and fascia are experiencing severe deterioration.

The issue is not limited to around the immediate windows area only, it is impacting the entire framing, sheathing and insulation below the windows.

Given that the HOA is looking into total window replacement of old non-rated windows to Hurricane rated windows, it is recommended to consider removing the interior drywall and insulation to expose the stud wall channels and plywood sheathing from the inside of the room.

- 1) Repair/replace locally in kind
- 2) Replace the entire plywood sheathing with new plywood or dense glass type sheathing (Owner's preference) along with insulation and dry walls after installation of the new windows, in accordance with manufacturer's recommendations.
- 3) Re-apply the exterior stucco and the paint inside.
- 4) FE recommends following the repair/replacement Shown in Attachment-A, included in this report.

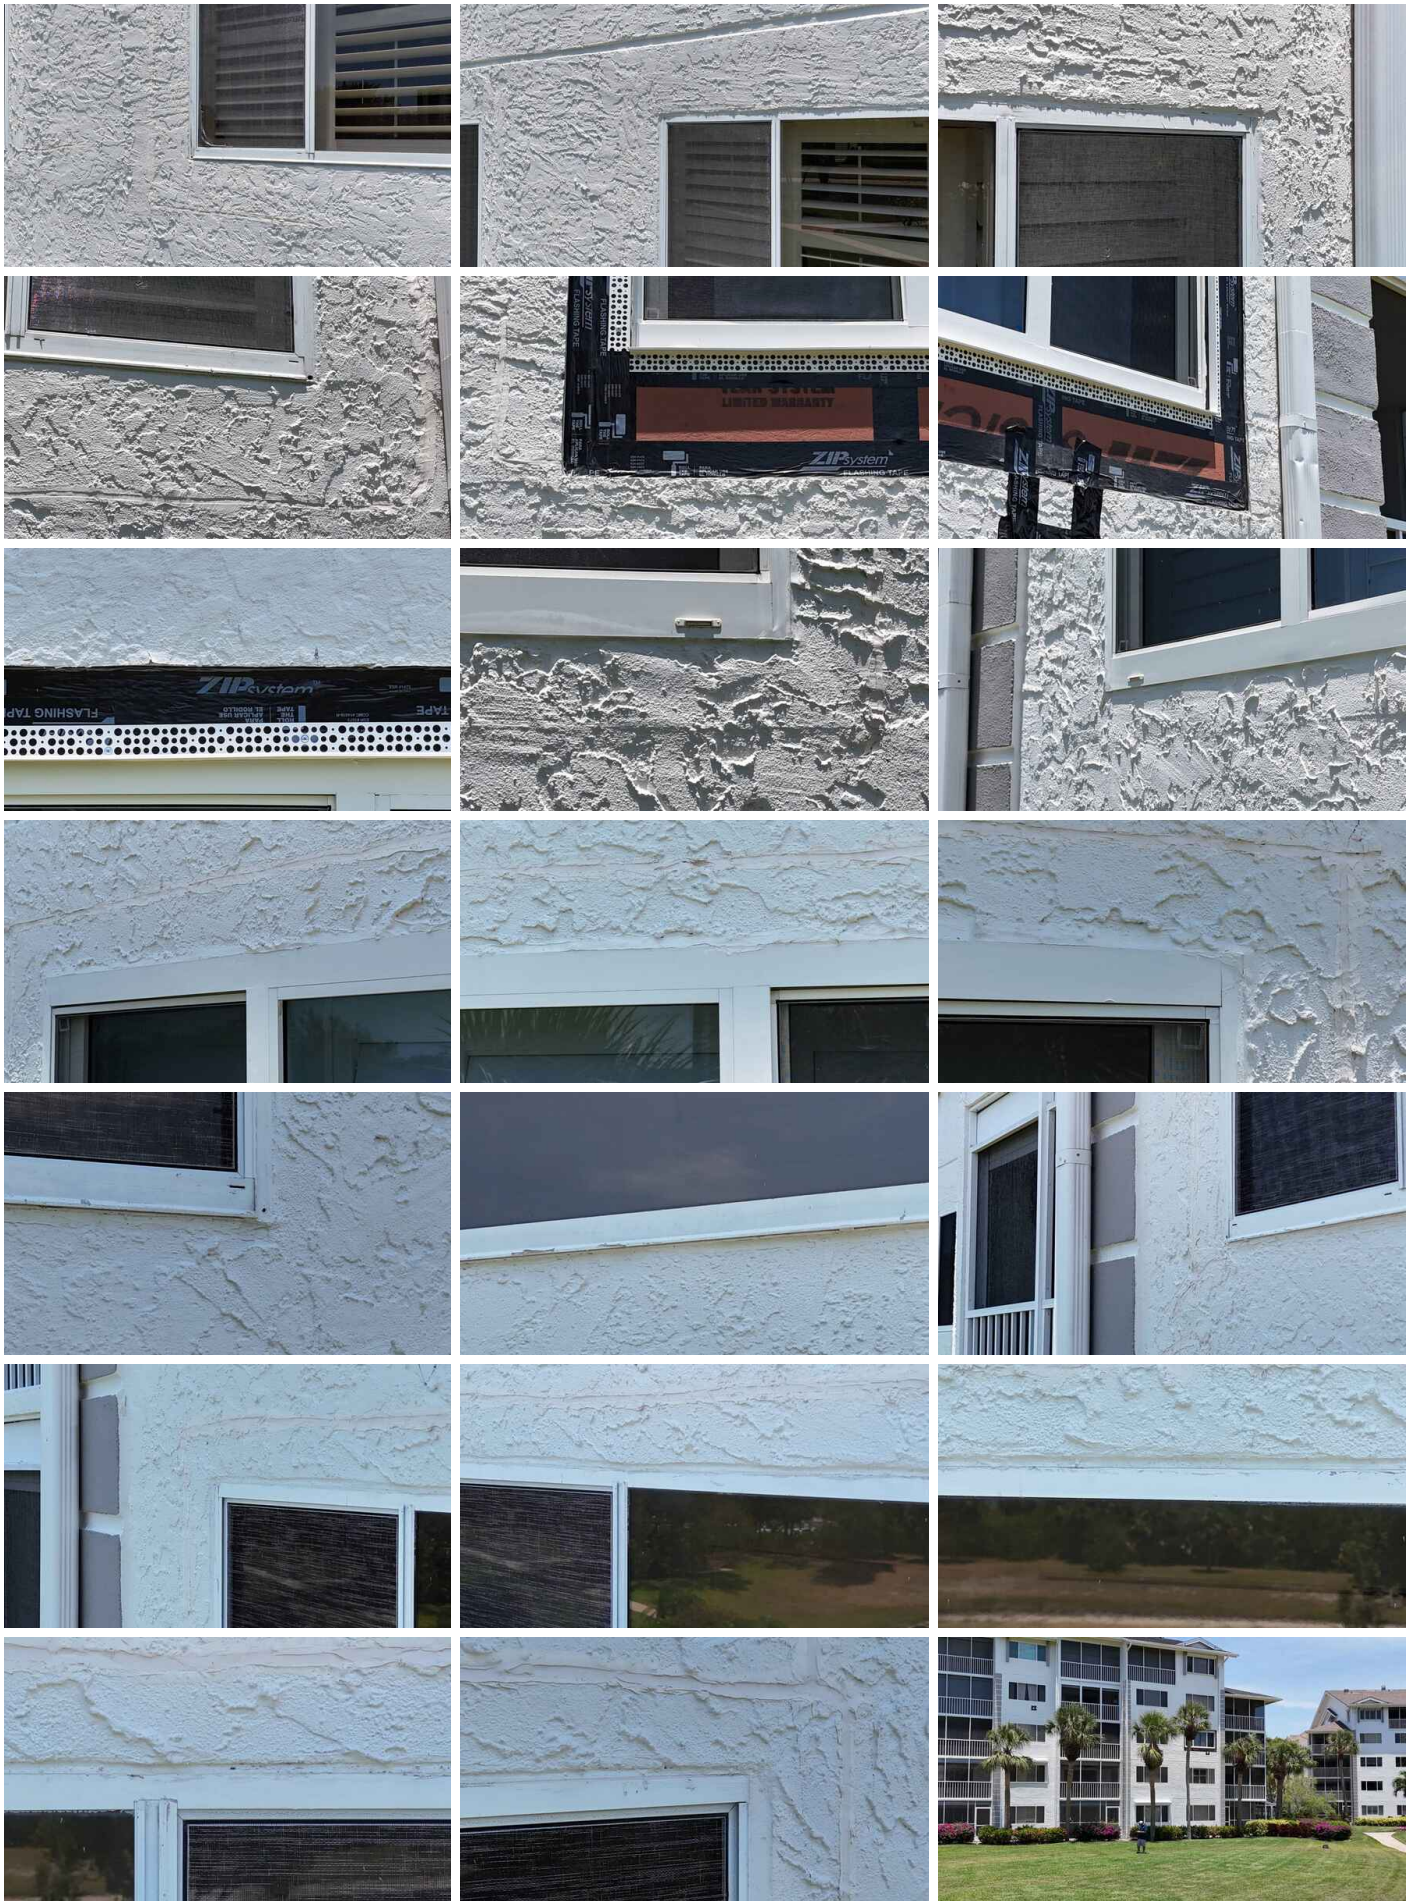
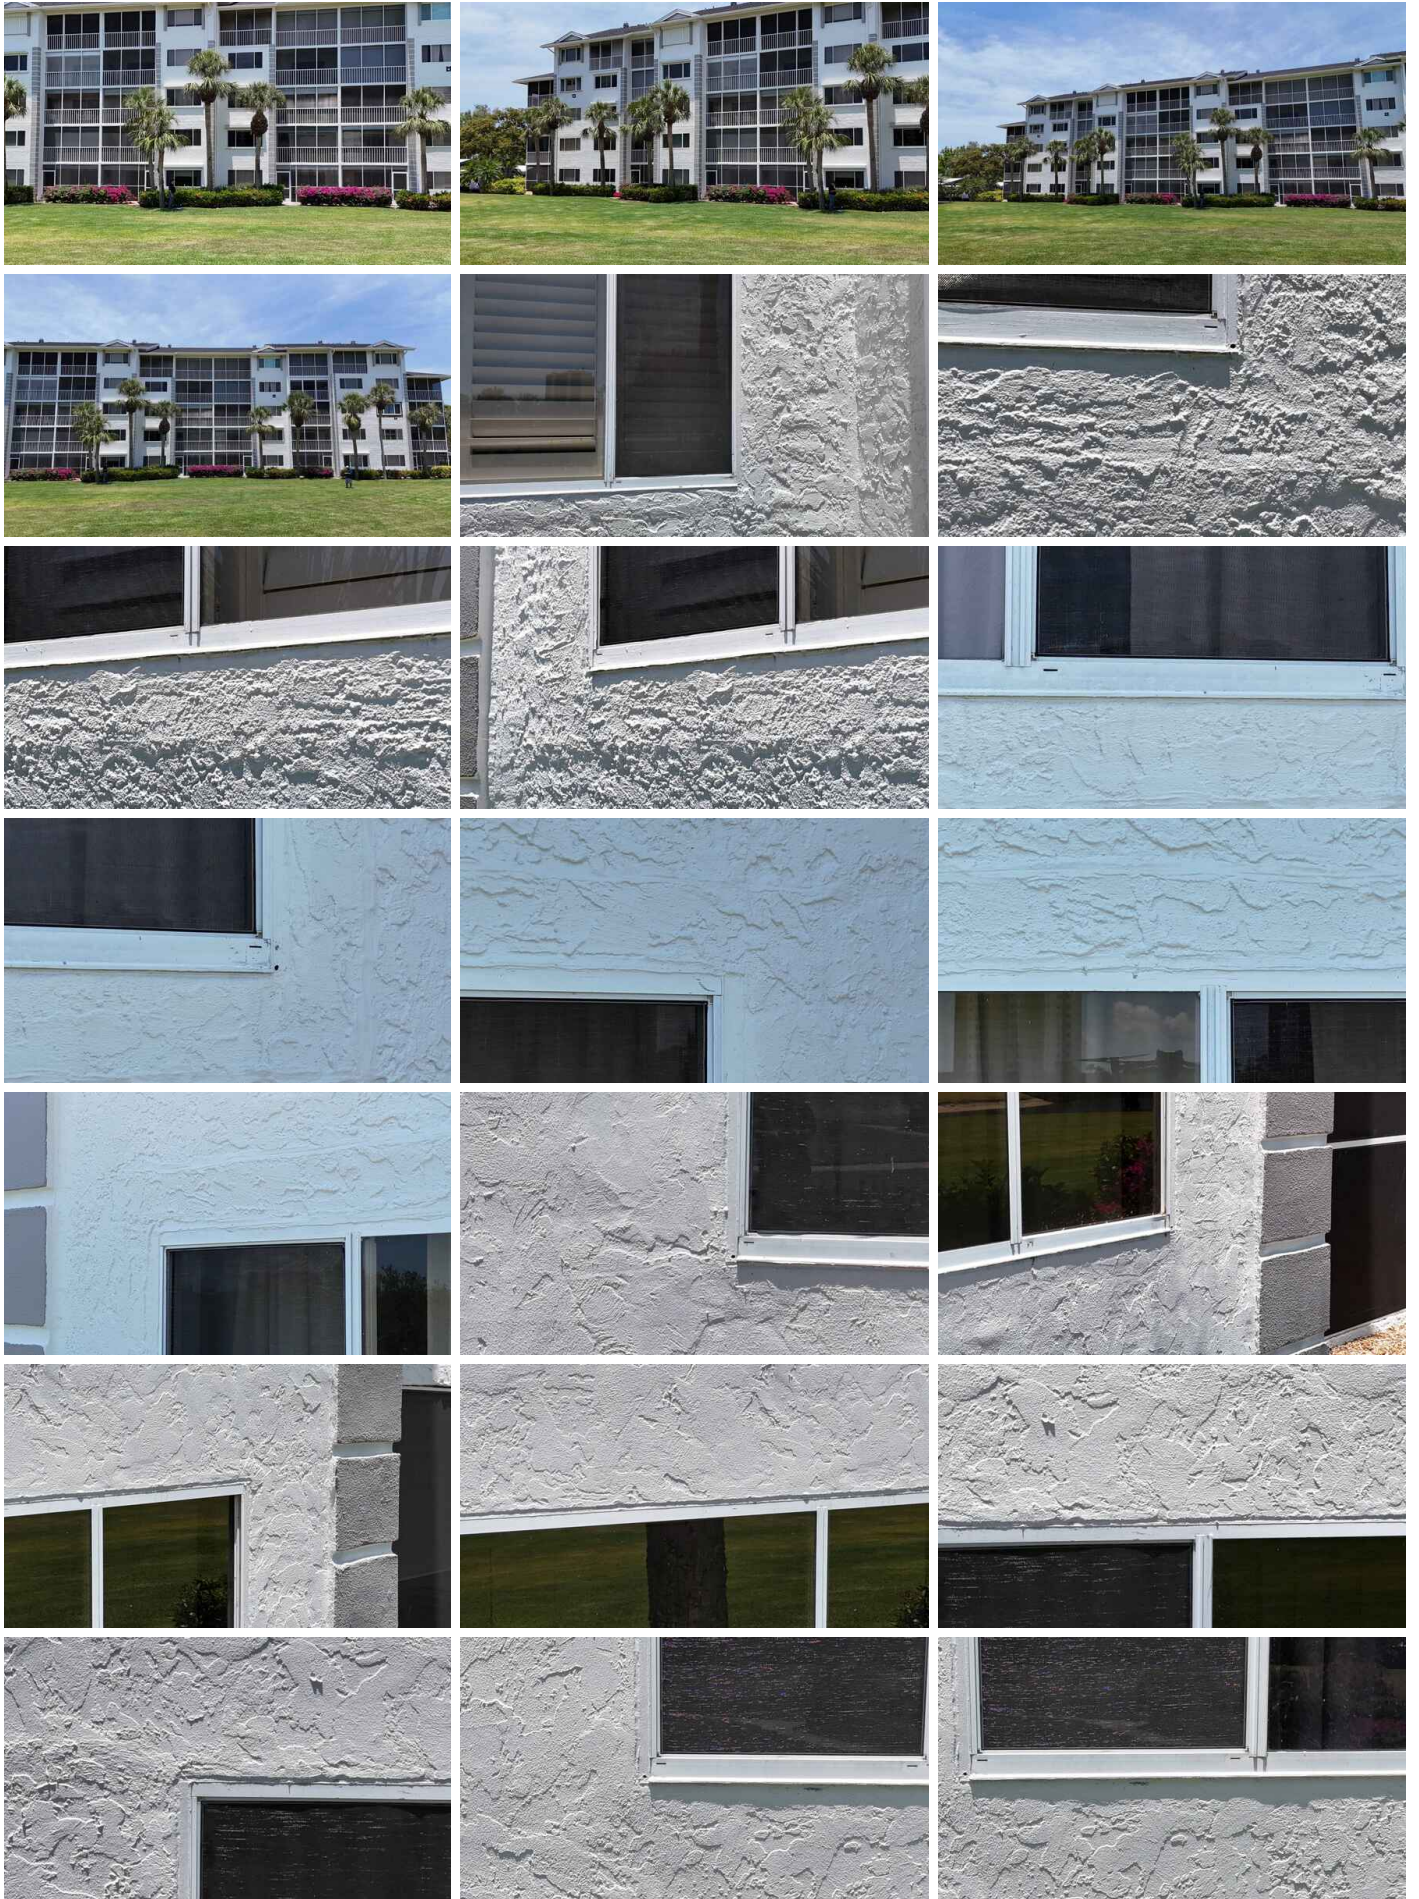
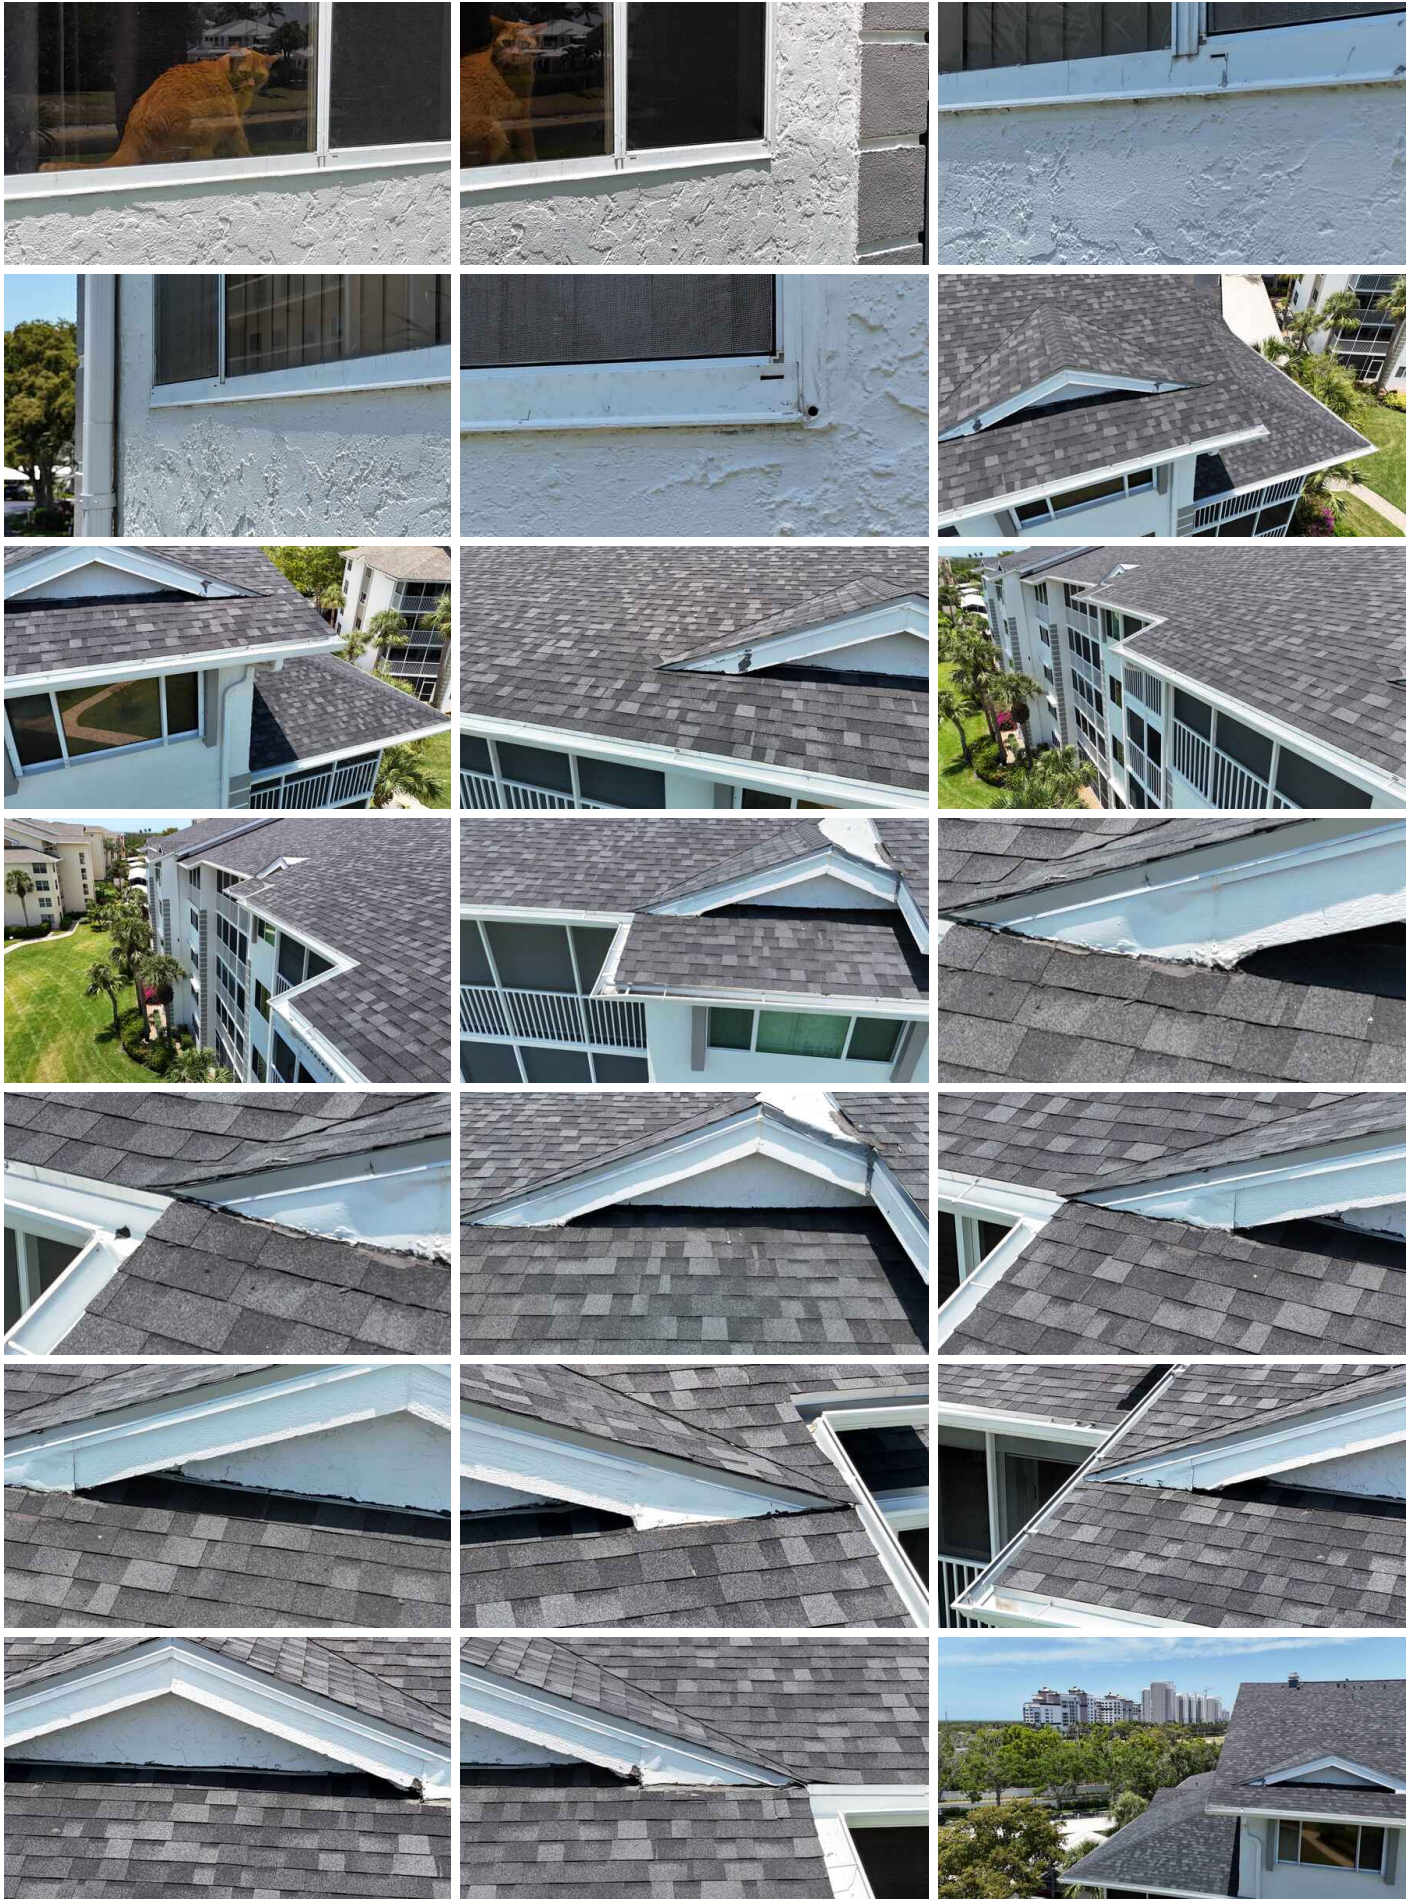
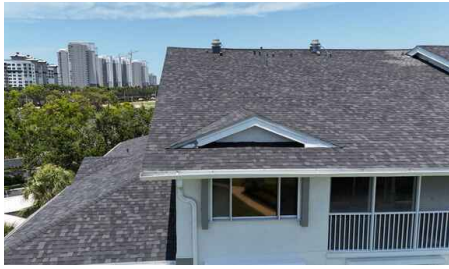
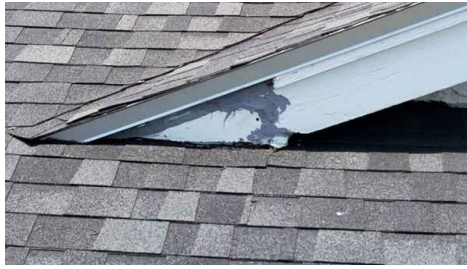
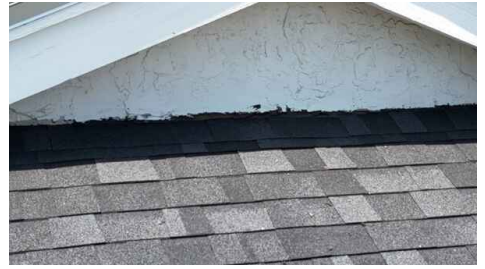
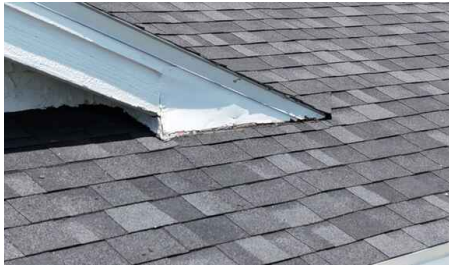
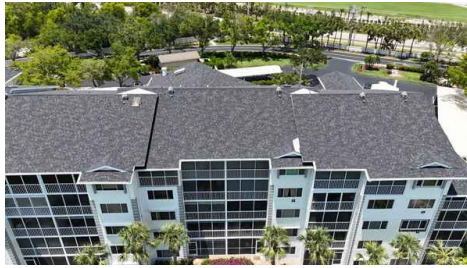
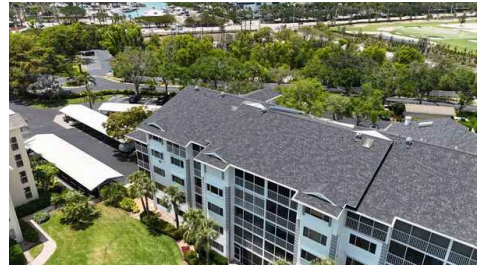
Drone Images

In addition to the back wall observations that some stucco cracks are visible in the back wall areas, there are visible damages to the roof flashings as well. The stucco cracks issues may be resolved with the back wall replacement, however the the roof flashings needs to be repaired/replaced as deemed required.
